Preliminary Water Quality Management Plan

Project Title: Orchard Logistics Center

Design Review/Case No: PW2021-0854

**GEOTECHNICAL INVESTIGATION
PROPOSED INDUSTRIAL BUILDING**

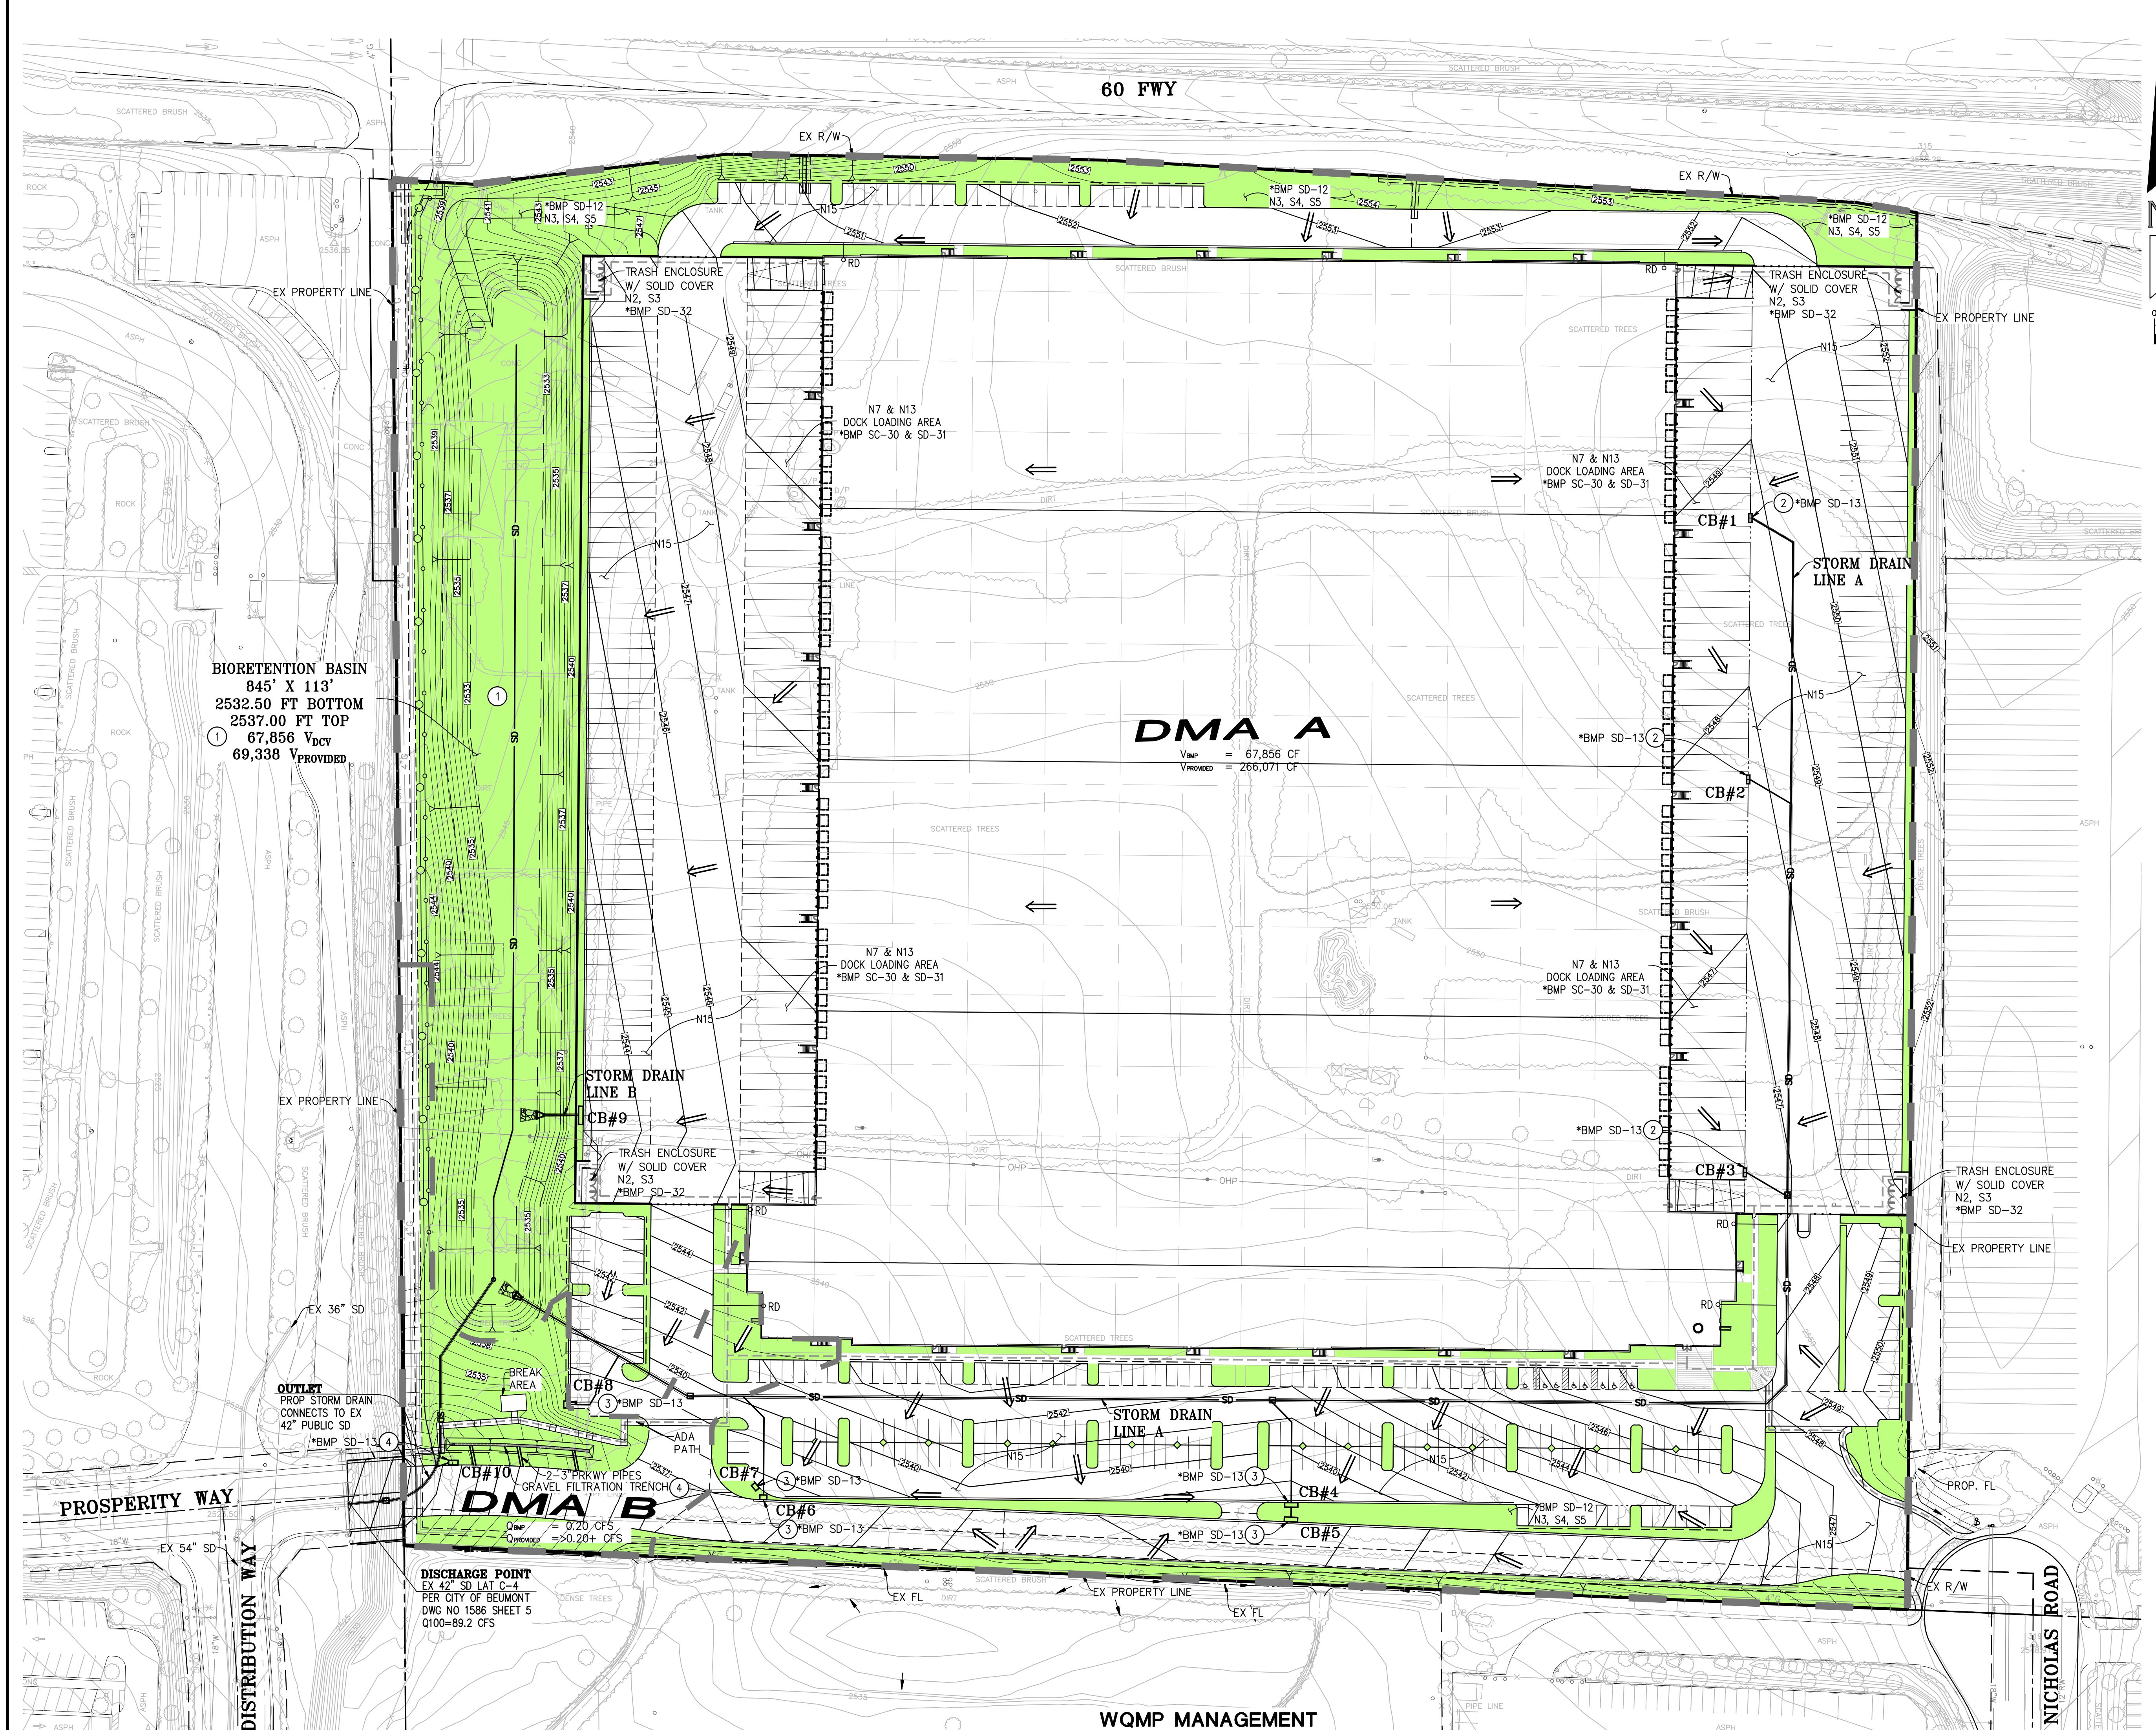
WQMP MANAGEMENT

- SD PROPOSED STORM DRAIN
- FLOW PROPOSED FLOWLINE
- DRAINAGE AREA BOUNDARY
- PROPOSED CATCH BASIN INLET, SOURCE CONTROL BMP: N1, N14, N17, & S1
- PROPOSED LANDSCAPING AREA - BMP SD-10 & SD-12 SOURCE CONTROL BMP: N3, S4, & S5
- CB CATCH BASIN
- RD ROOF DRAIN
- FLOW DIRECTION
- INLET STRUCTURE W/ RIP-RAP

SCALE 1" = 60'

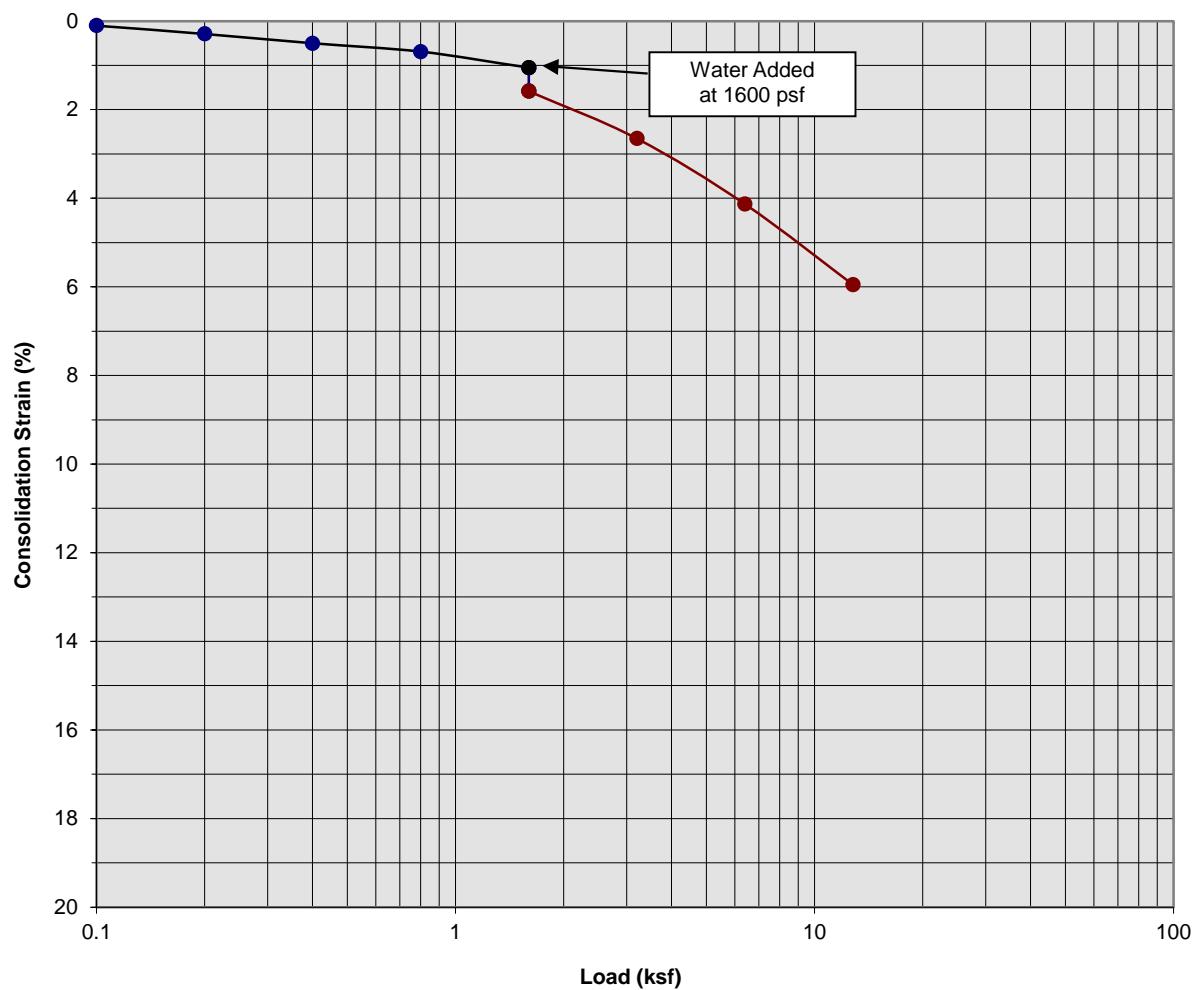
Consolidation/Collapse Test Results

Classification: Red Brown Silty fine Sand, little medium Sand and Clay

| Boring Number: | B-1 | Initial Moisture Content (%) | 13 |

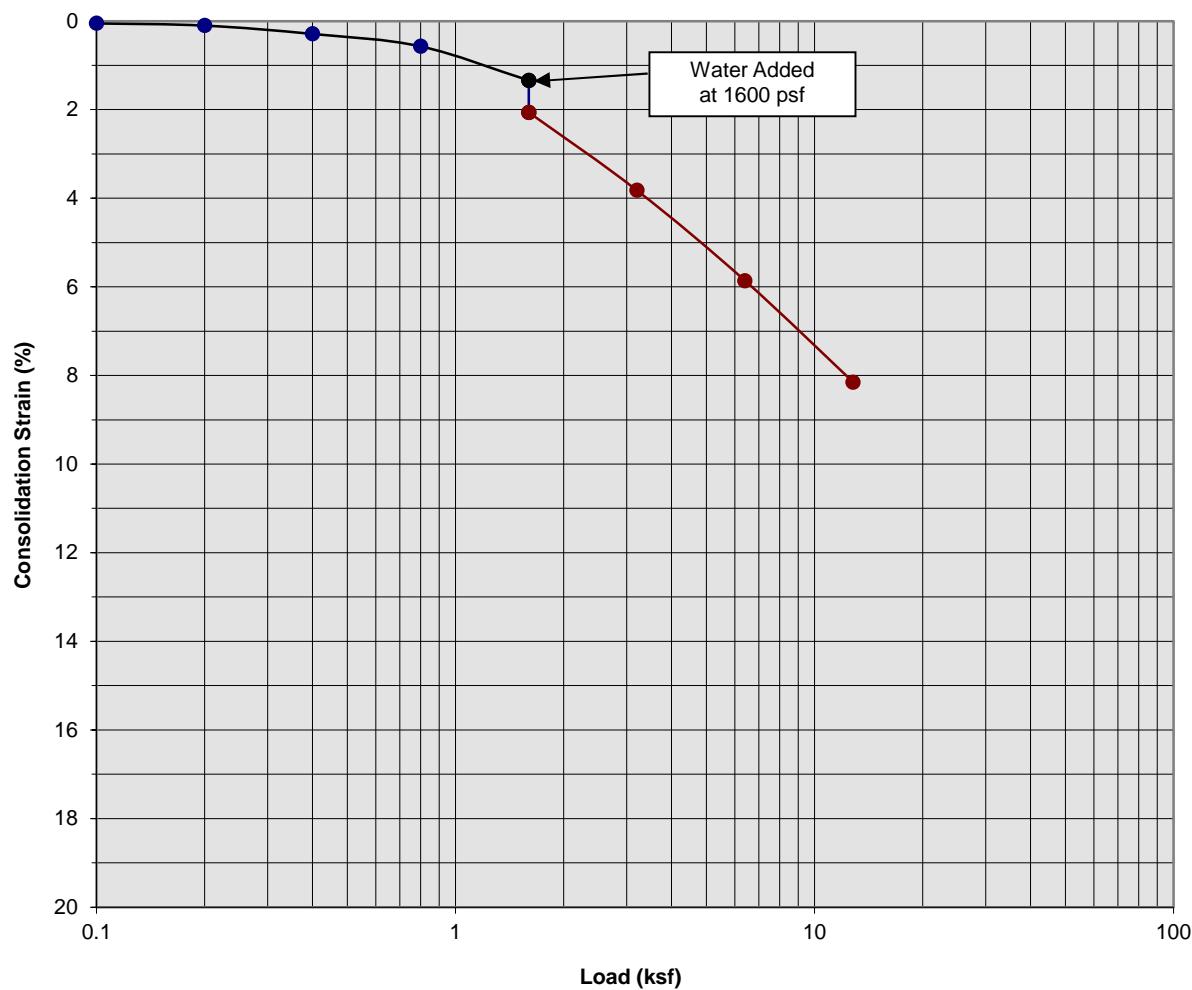
Consolidation/Collapse Test Results

Classification: Red Brown Silty fine Sand, little medium Sand and Clay

| Boring Number: | B-1 | Initial Moisture Content (%) | 11 |

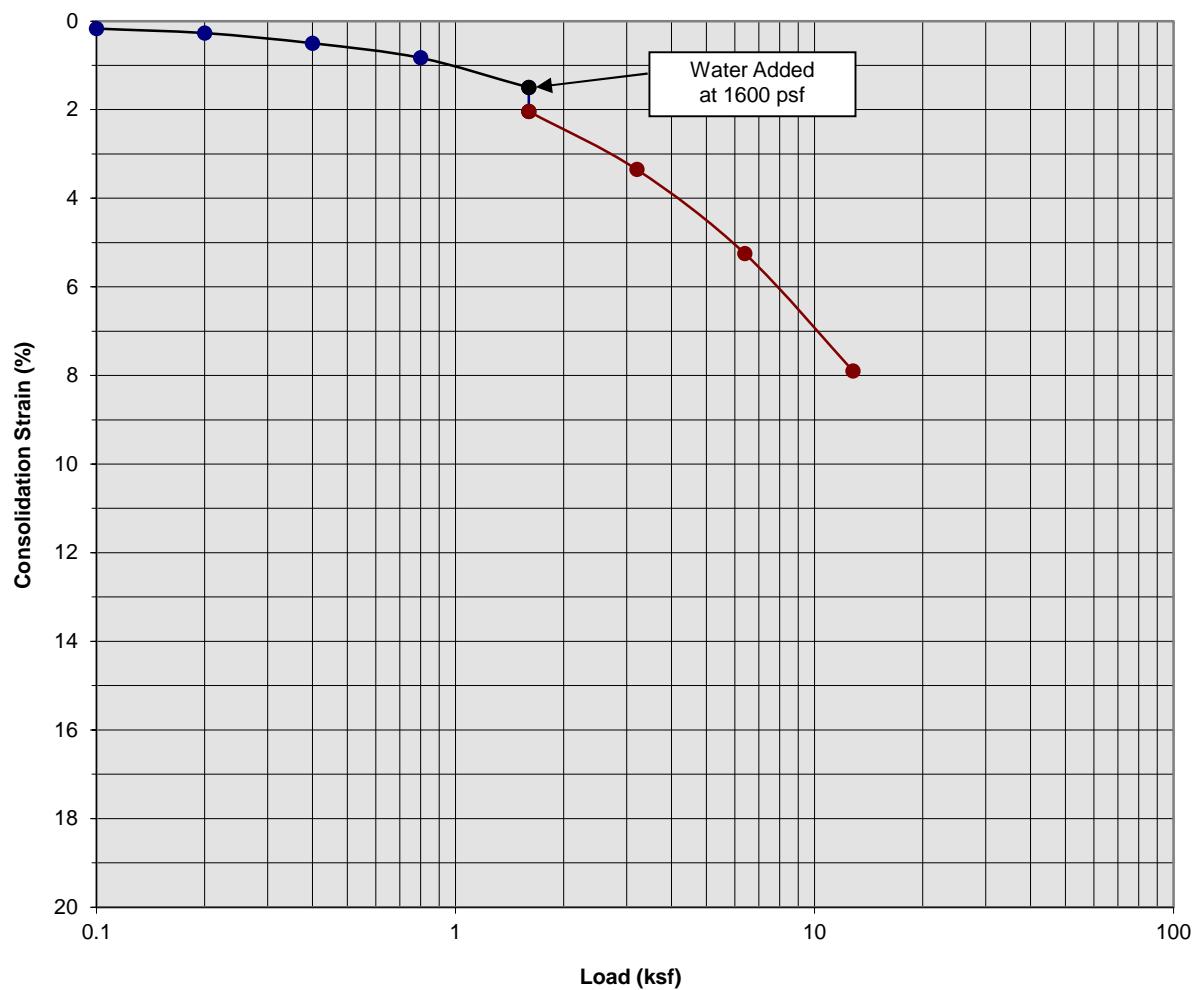
Consolidation/Collapse Test Results

Classification: Red Brown Silty fine Sand to fine Sandy Silt, little Clay

| Boring Number: | B-1 | Initial Moisture Content (%) | 13 |
| Specimen Thickness (in) | 1.0 | Percent Collapse (%) | 0.54 |

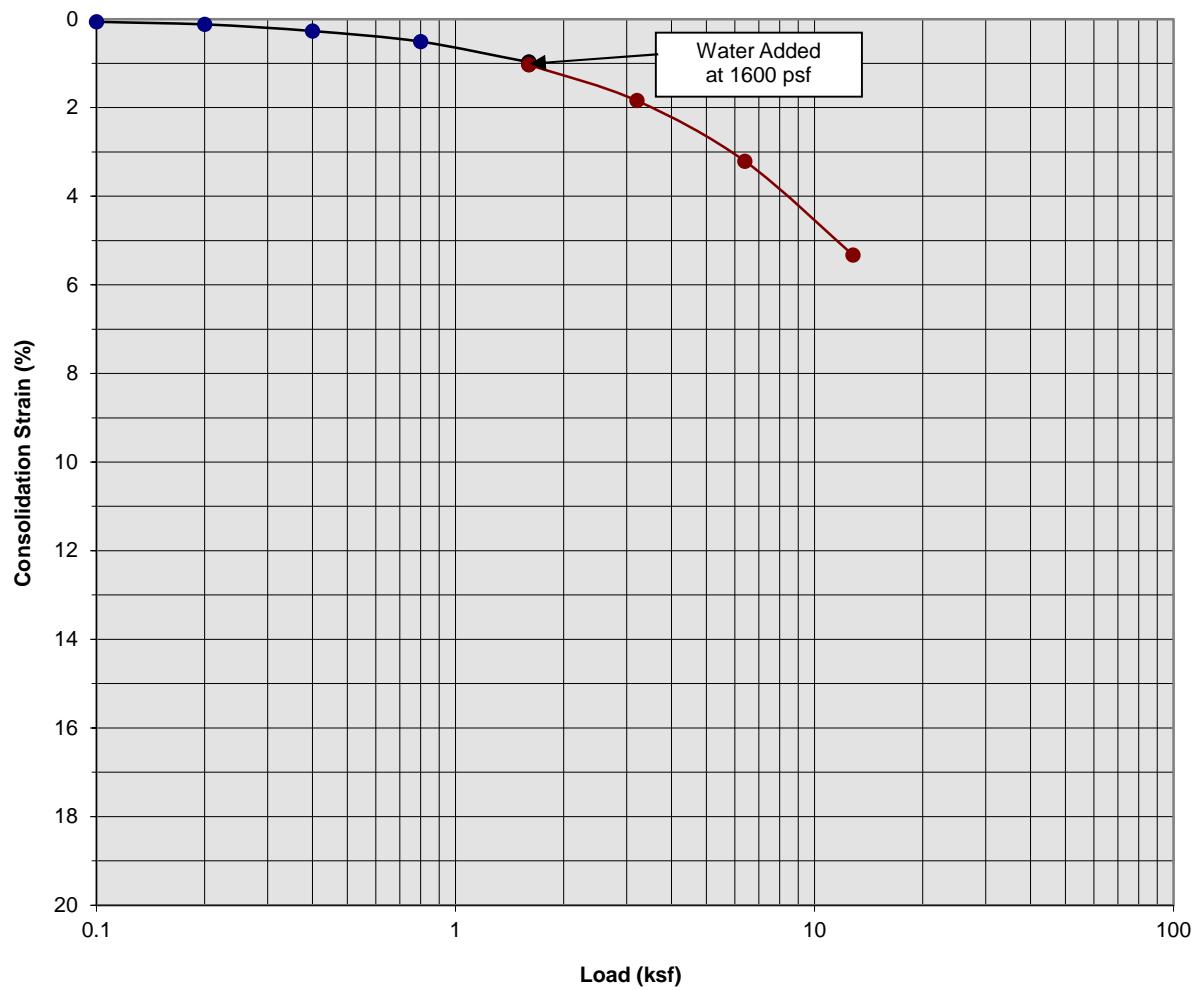
Consolidation/Collapse Test Results

Classification: Red Brown Silty fine Sand to fine Sandy Silt, little Clay

| Boring Number: | B-1 | Initial Moisture Content (%) | 17 |

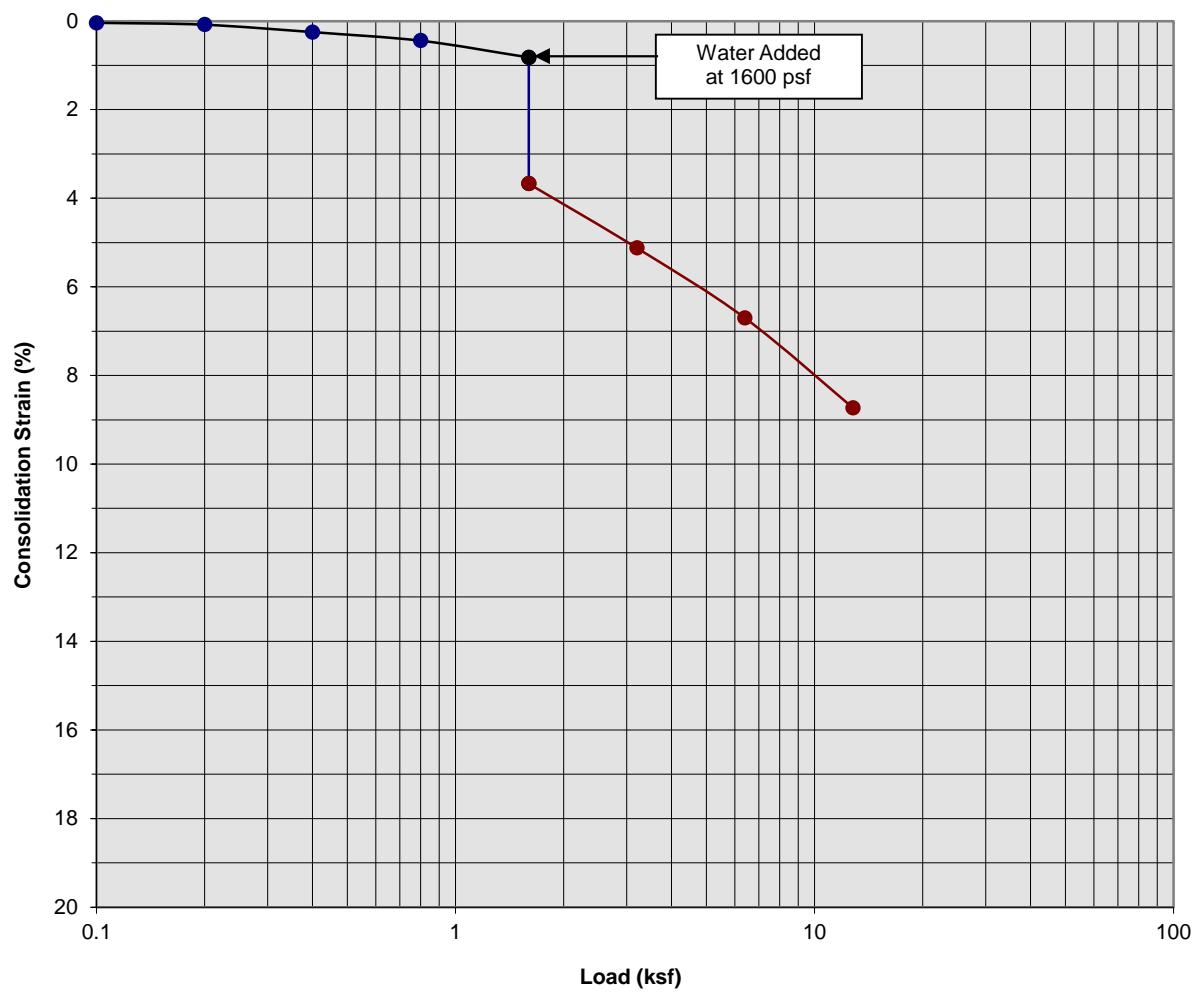
Consolidation/Collapse Test Results

Classification: Red Brown Clayey fine to medium Sand

| Boring Number: | B-3 | Initial Moisture Content (%) | 11 |
| Specimen Thickness (in) | 1.0 | Percent Collapse (%) | 2.85 |

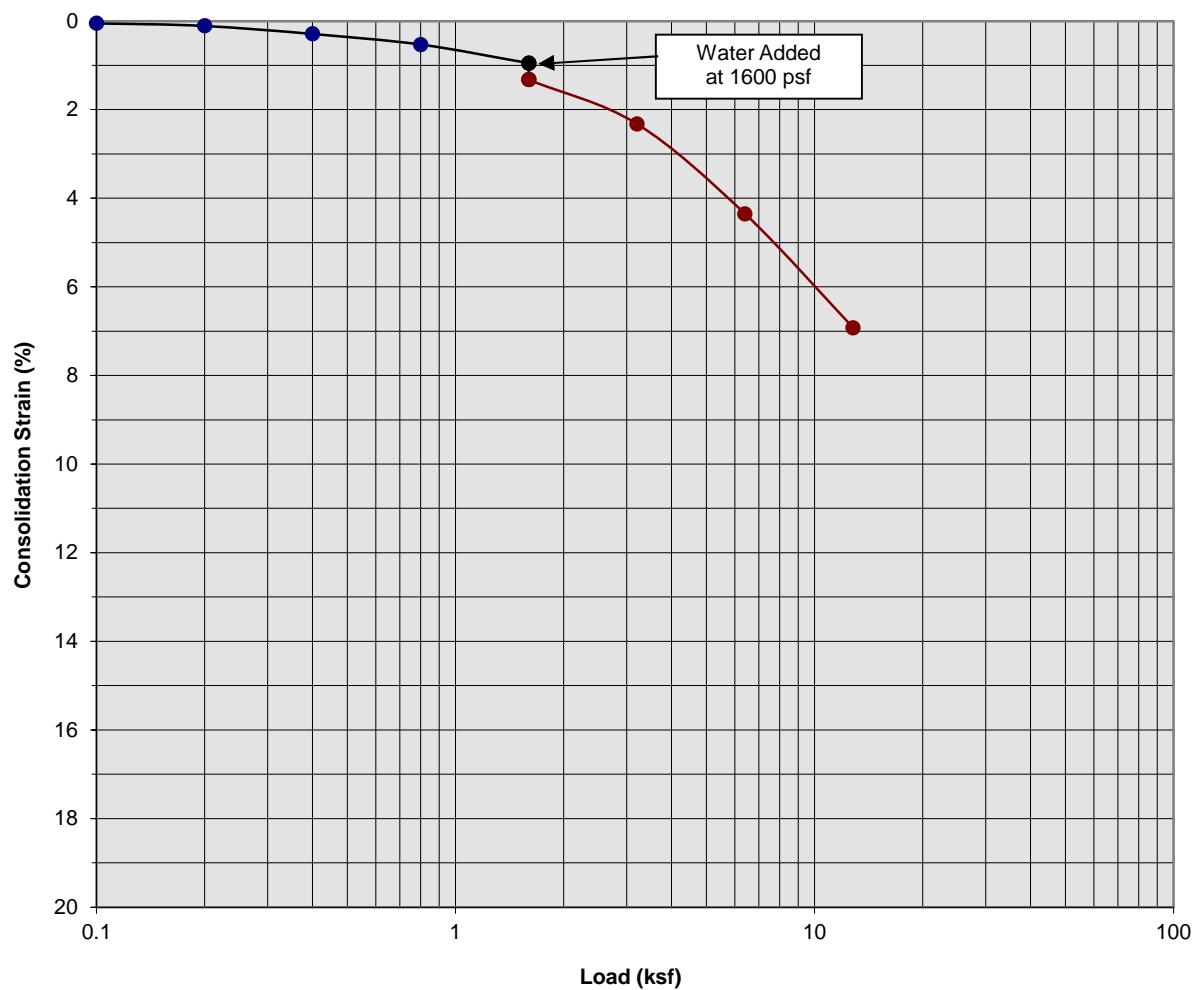
Consolidation/Collapse Test Results

Classification: Red Brown fine Sandy Silt, little Clay

| Boring Number: | B-3 | Initial Moisture Content (%) | 18 |
| Specimen Thickness (in) | 1.0 | Percent Collapse (%) | 0.37 |

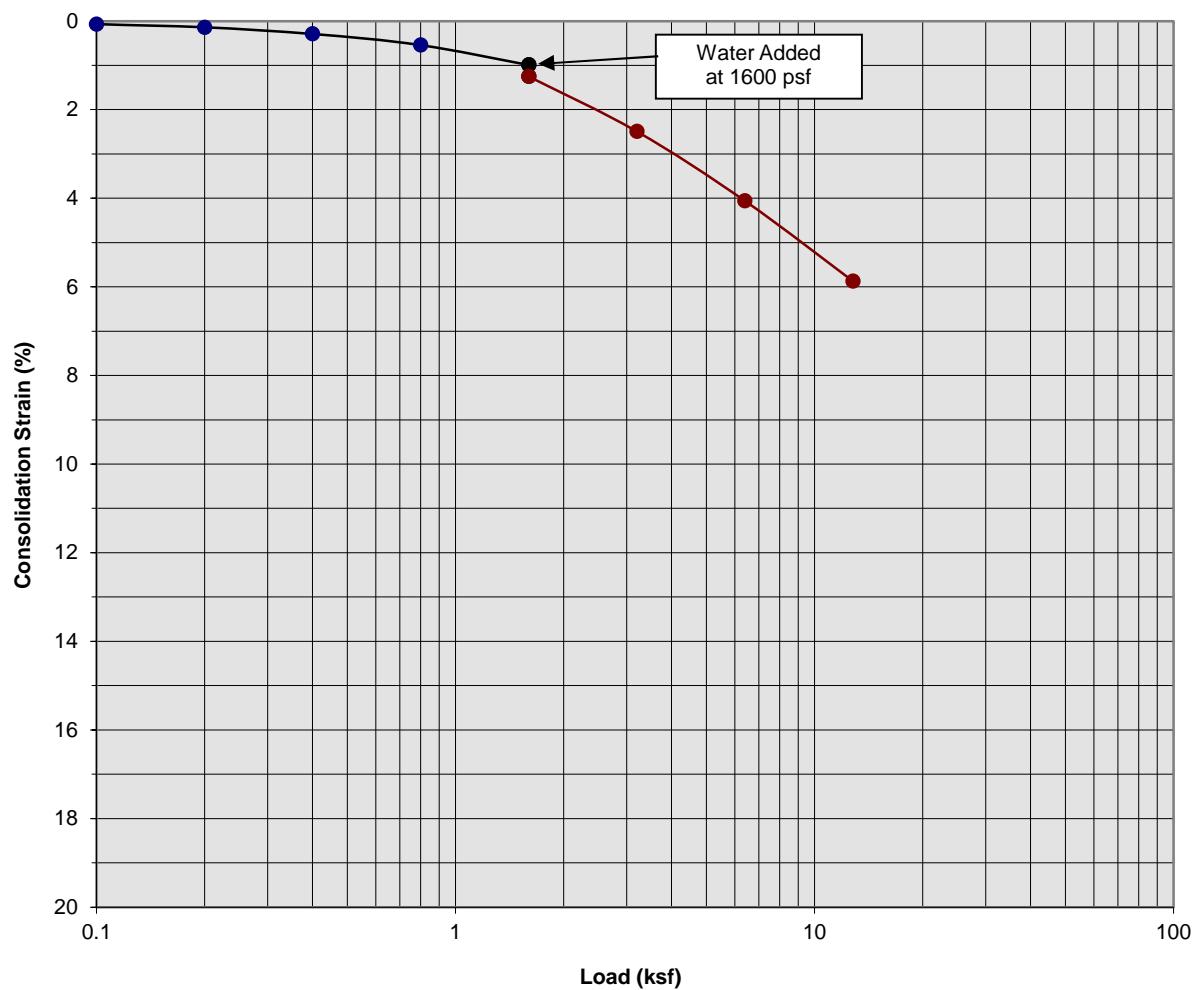
Consolidation/Collapse Test Results

Classification: Red Brown Silty fine Sand, little Clay

| Boring Number: | B-3 | Initial Moisture Content (%) | 5 |

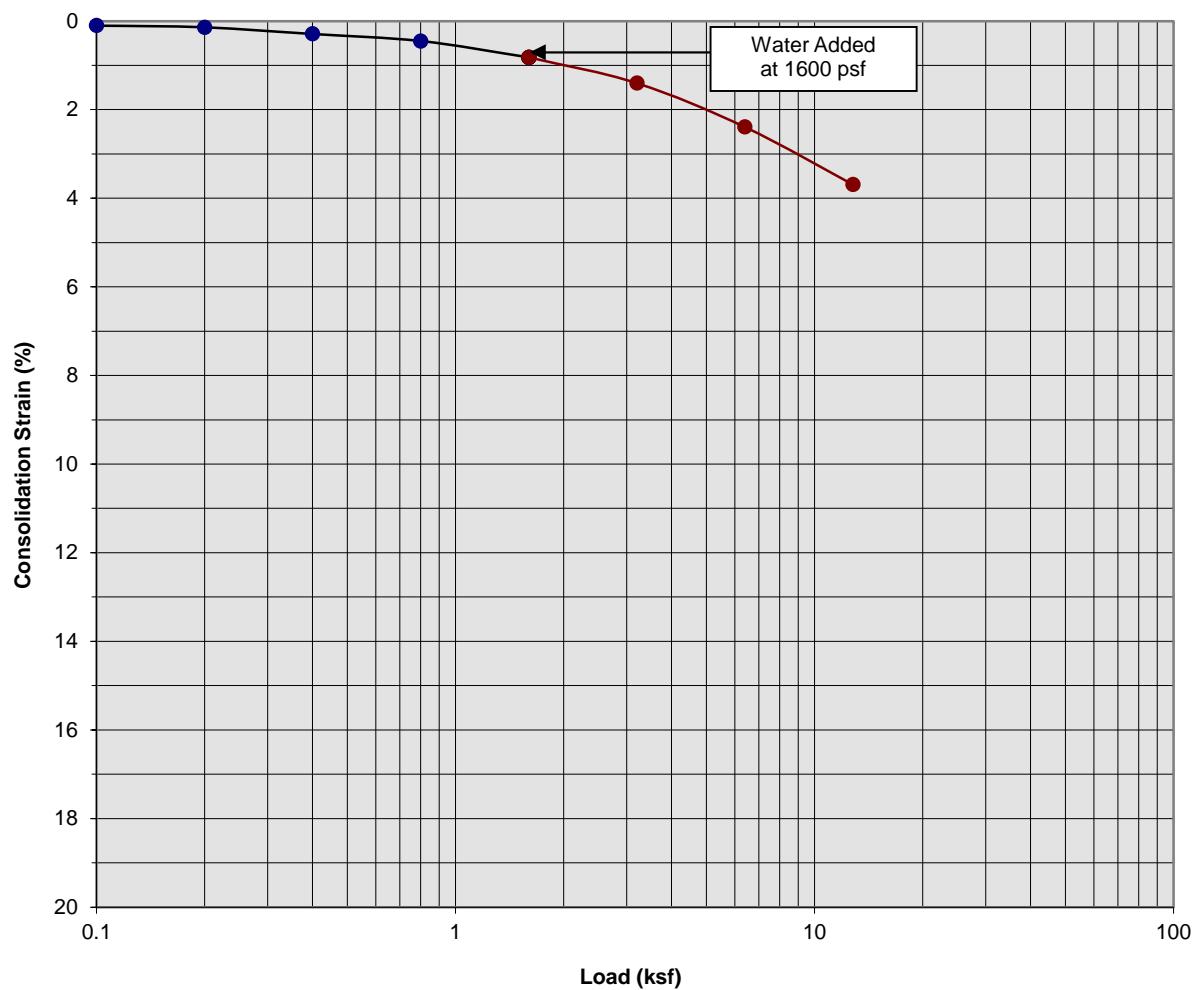
Consolidation/Collapse Test Results

Classification: Brown fine Sandy Silt, some Clay

| Boring Number: | B-3 | Initial Moisture Content (%) | 17 |
| Specimen Thickness (in) | 1.0 | Percent Collapse (%) | 0.00 |

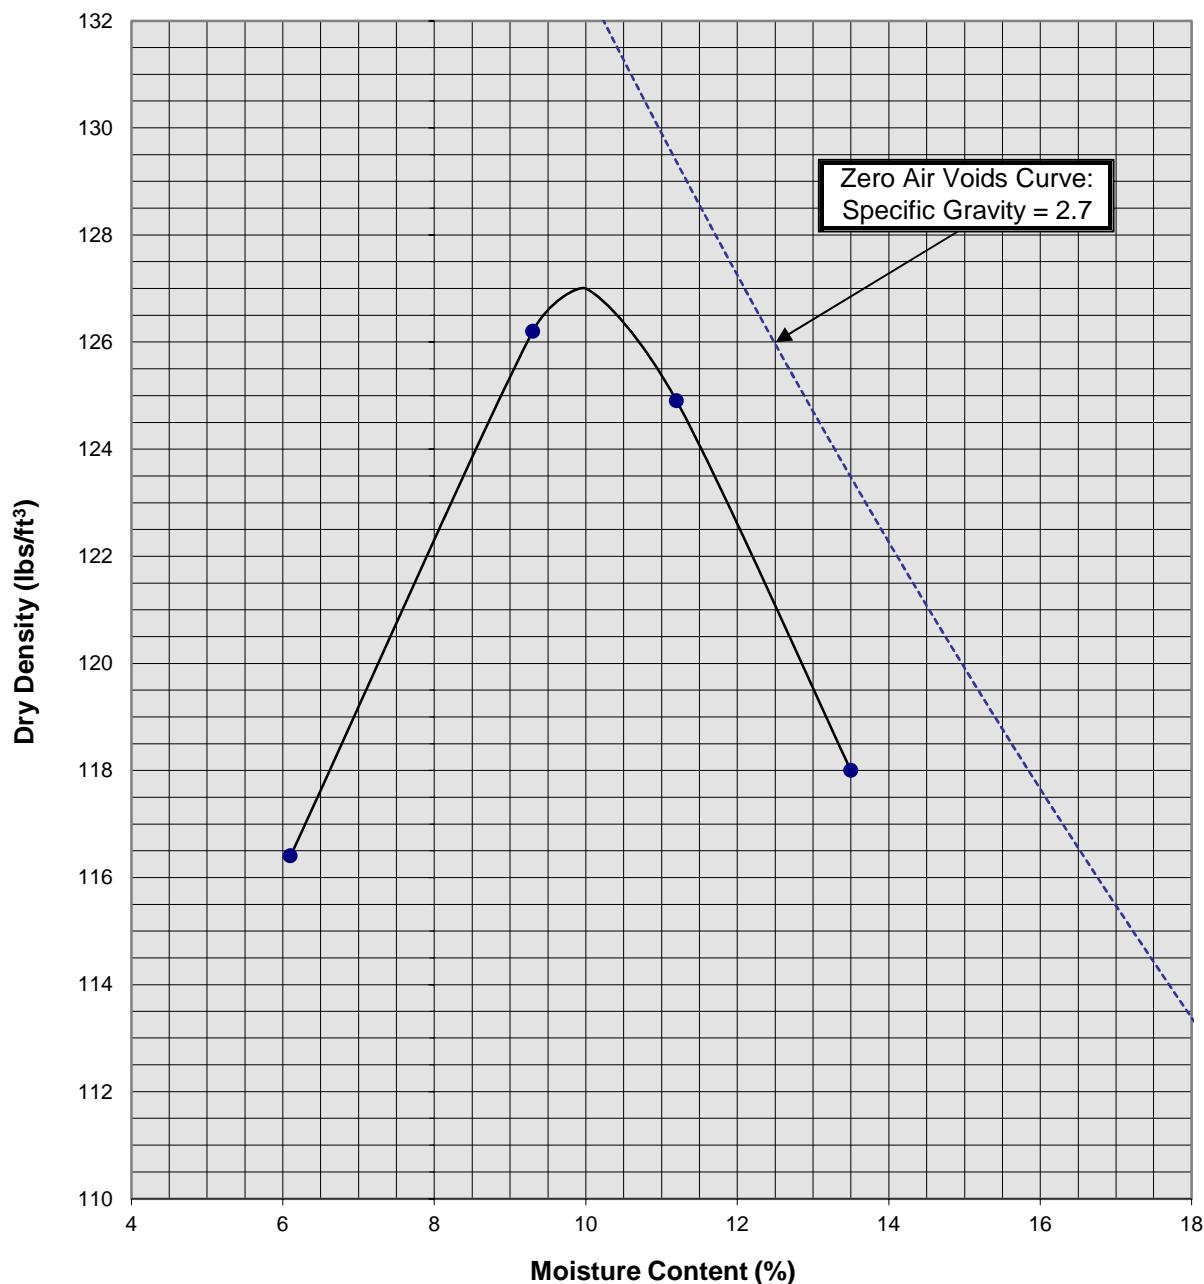
Moisture/Density Relationship
ASTM D-1557

| Soil ID Number | B-6 @ 0-5' |
| Optimum Moisture (%) | 10 |

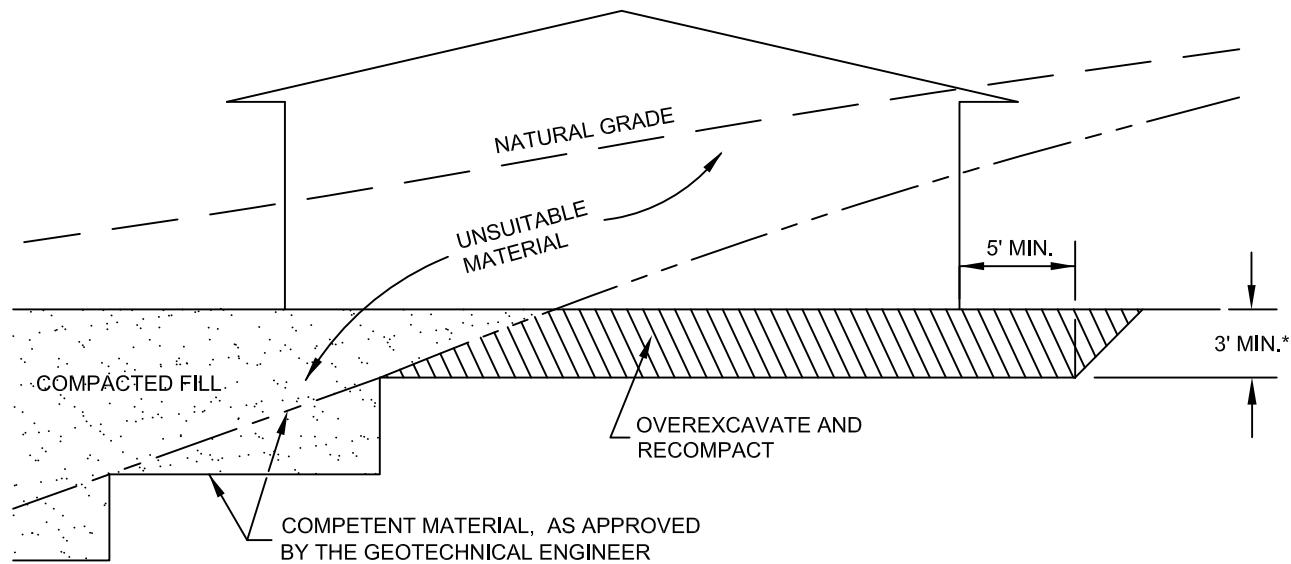
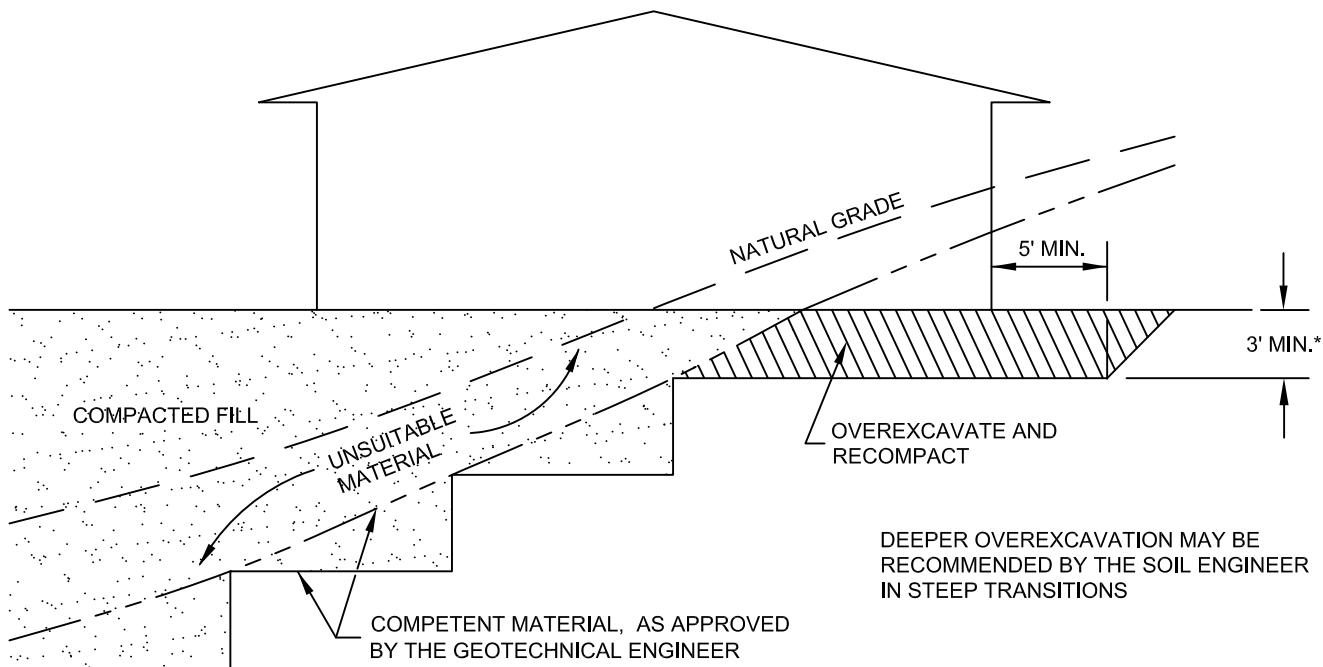
| TRANSITION LOT DETAIL | |

CUT LOT

CUT/FILL LOT (TRANSITION)

*SEE TEXT OF REPORT FOR SPECIFIC RECOMMENDATION.
ACTUAL DEPTH OF OVEREXCAVATION MAY BE GREATER.

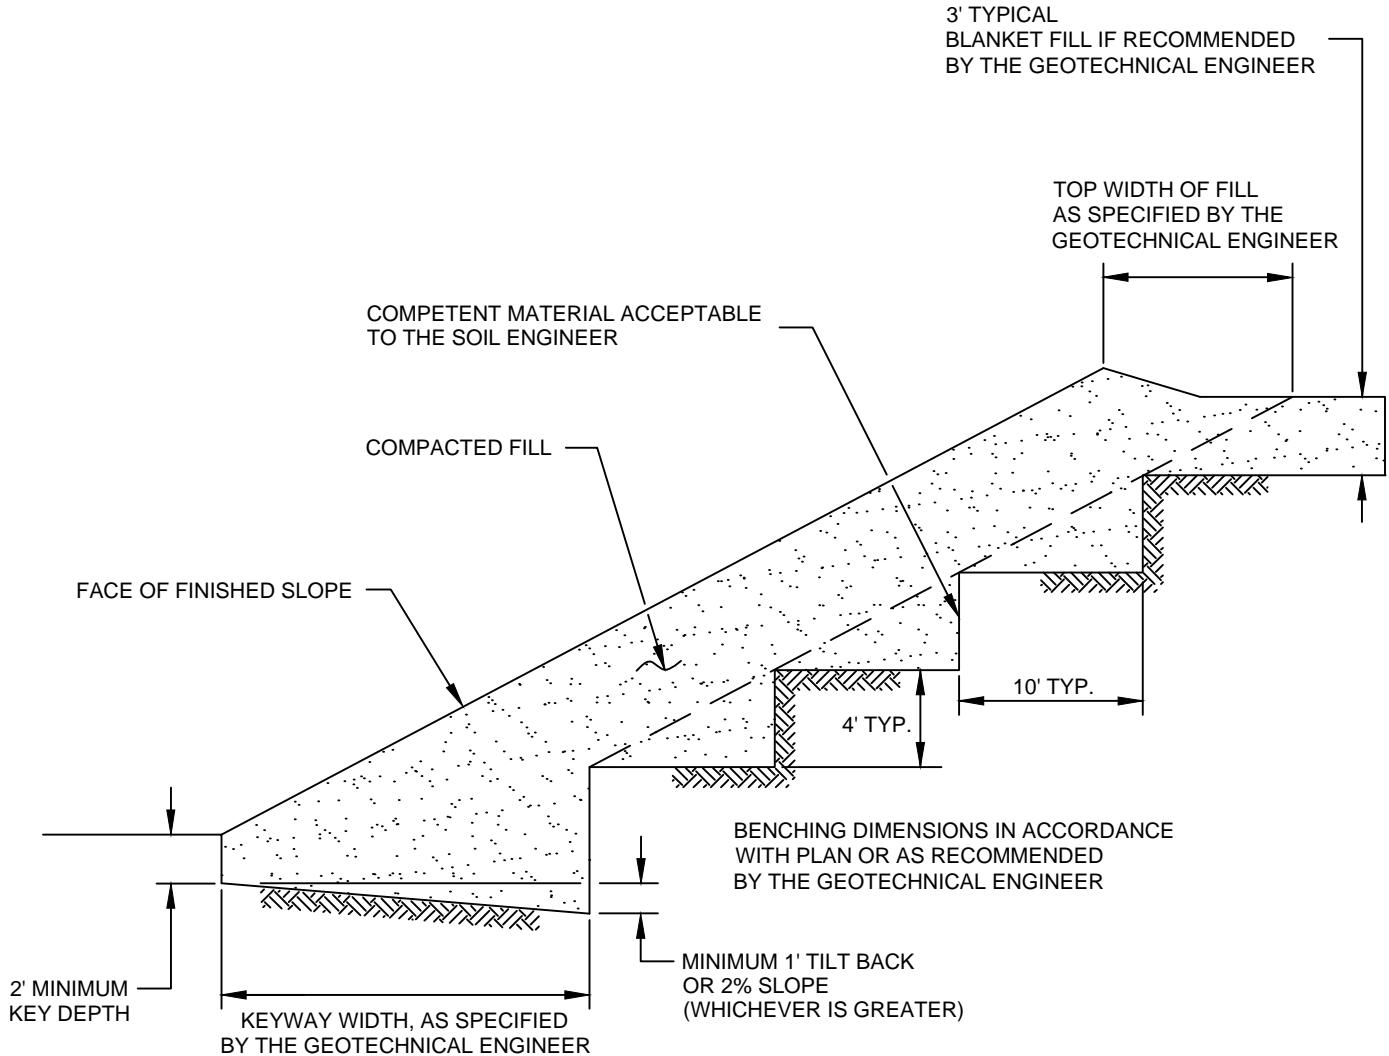
STABILIZATION FILL DETAIL TRADING GUIDE SPECIFICATIONS

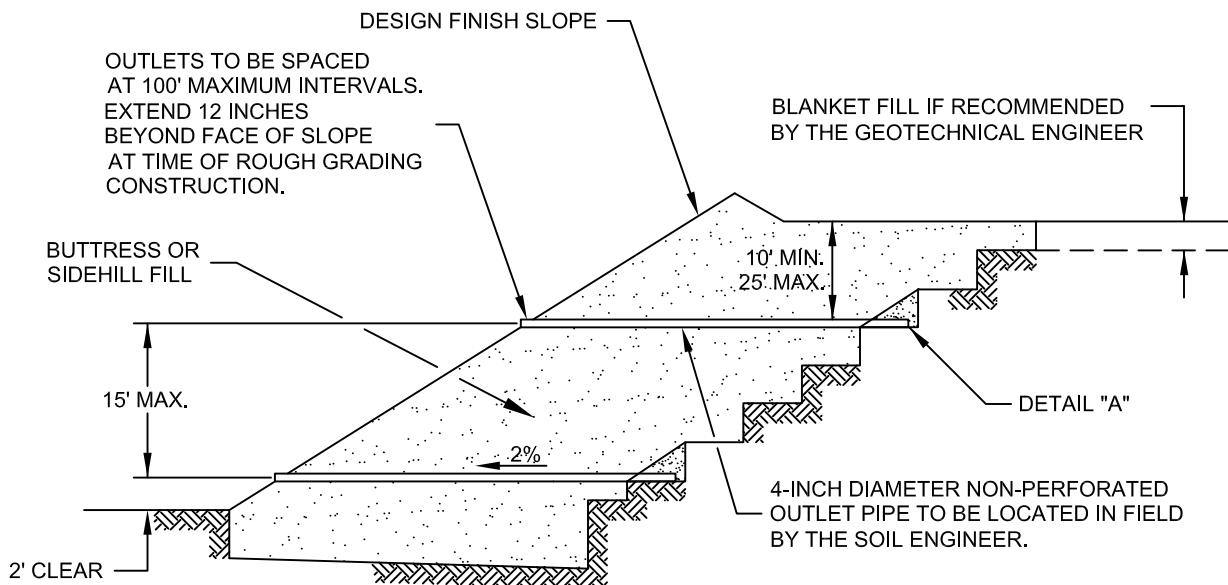
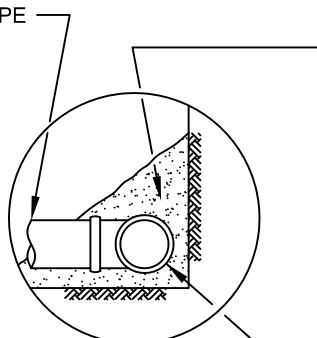
DETAIL "A"

"FILTER MATERIAL" TO MEET FOLLOWING SPECIFICATION OR APPROVED EQUIVALENT: (CONFORMS TO EMA STD. PLAN 323)

OUTLET PIPE TO BE CONNECTED TO SUBDRAIN PIPE WITH TEE OR ELBOW

FILTER MATERIAL - MINIMUM OF FIVE CUBIC FEET PER FOOT OF PIPE. SEE ABOVE FOR FILTER MATERIAL SPECIFICATION.

- Filter material for subdrains should conform to CALTRANS Specification 68-1.025 or as approved by the Geotechnical Engineer for the specific site conditions. Clean $\frac{3}{4}$ -inch crushed rock may be used provided it is wrapped in an acceptable filter cloth and approved by the Geotechnical Engineer. Pipe diameters should be 6 inches for runs up to 500 feet and 8 inches for the downstream continuations of longer runs. Four-inch diameter pipe may be used in buttress and stabilization fills.

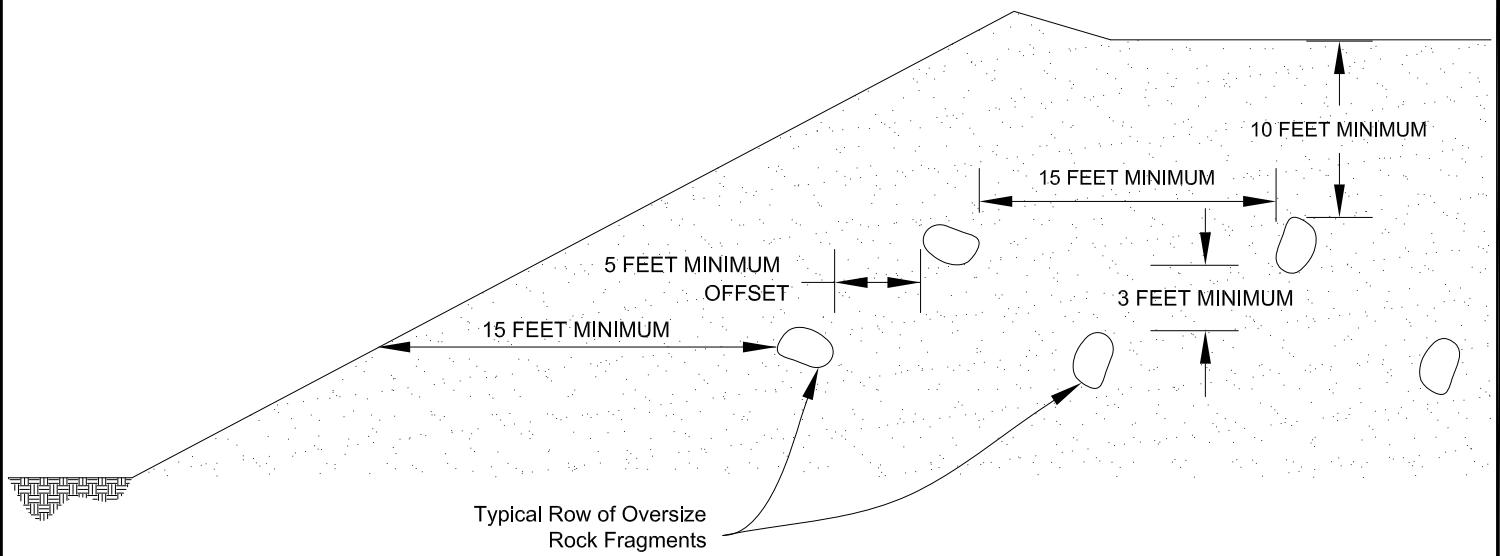
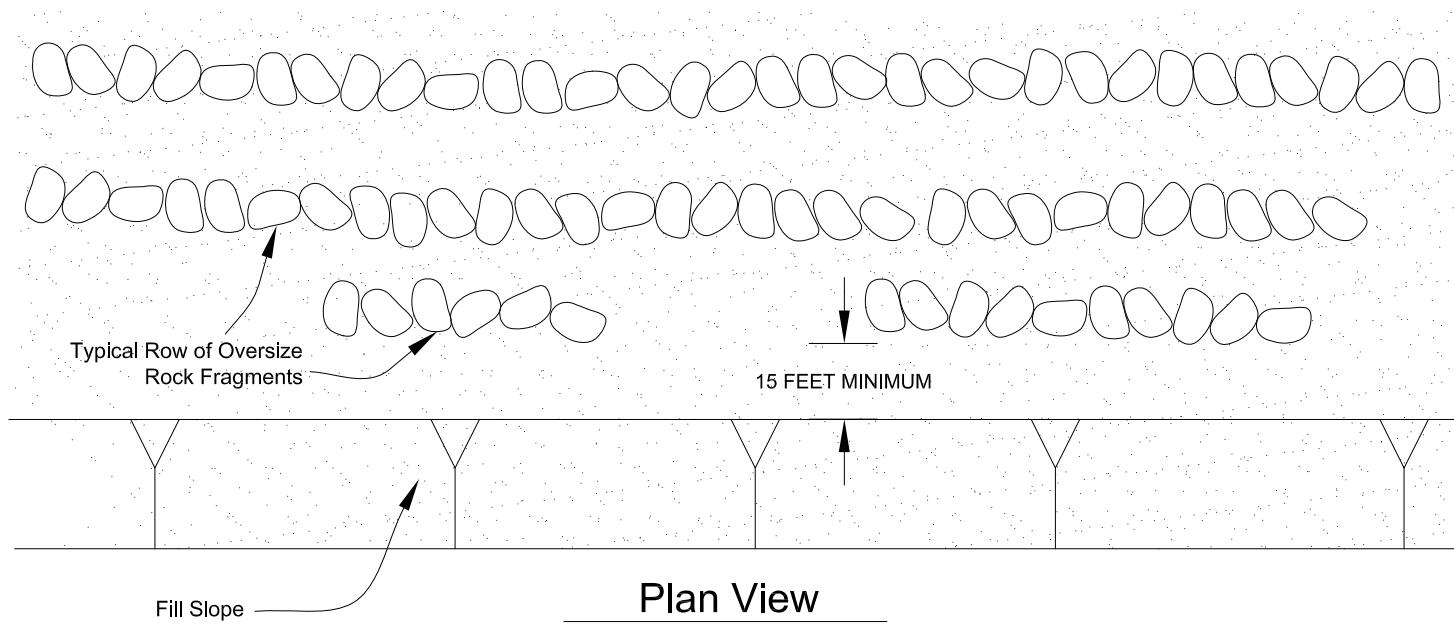
PLACEMENT OF OVERSIZED MATERIAL
GRADING GUIDE SPECIFICATIONS

Section View

Plan View
