Preliminary Water Quality Management Plan

Project Title: Orchard Logistics Center

Design Review/Case No: PW2021-0854

**GEOTECHNICAL INVESTIGATION
PROPOSED INDUSTRIAL BUILDING**

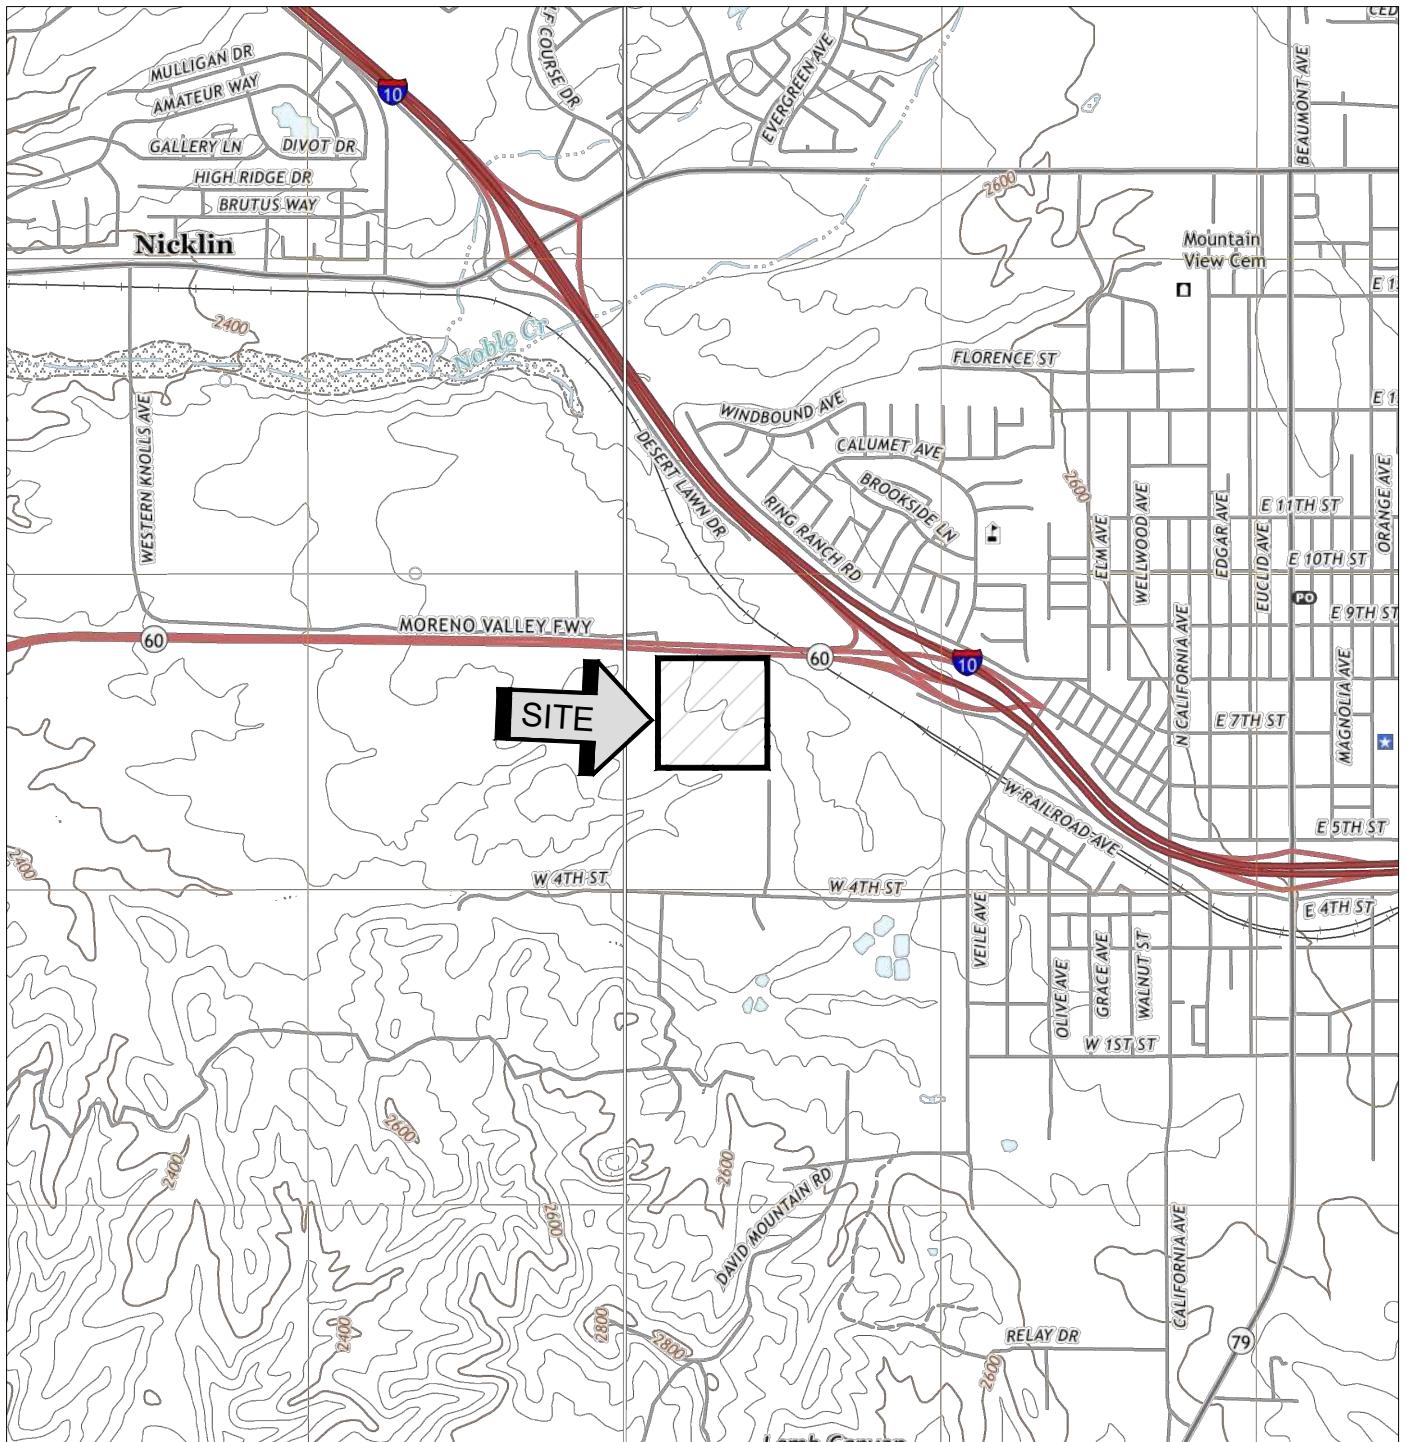
SOURCE: USGS TOPOGRAPHIC MAP OF THE BEAUMONT AND EL CASCO QUADRANGLES, RIVERSIDE COUNTY, CALIFORNIA, 2018.

The subject site is located immediately northwest of the terminus of the Nicholas Road cul-de-sac, 1300± feet north of the intersection with West 4th Street in Beaumont, California. The site is bounded to the north by the Moreno Valley Freeway (60), to the east by an existing industrial building, to the south by an existing commercial/industrial building and vacant land and to the west by Western Knolls Avenue and an Amazon distribution facility. The general location of the site is illustrated on the Site Location Map, included as Plate 1 of this report.

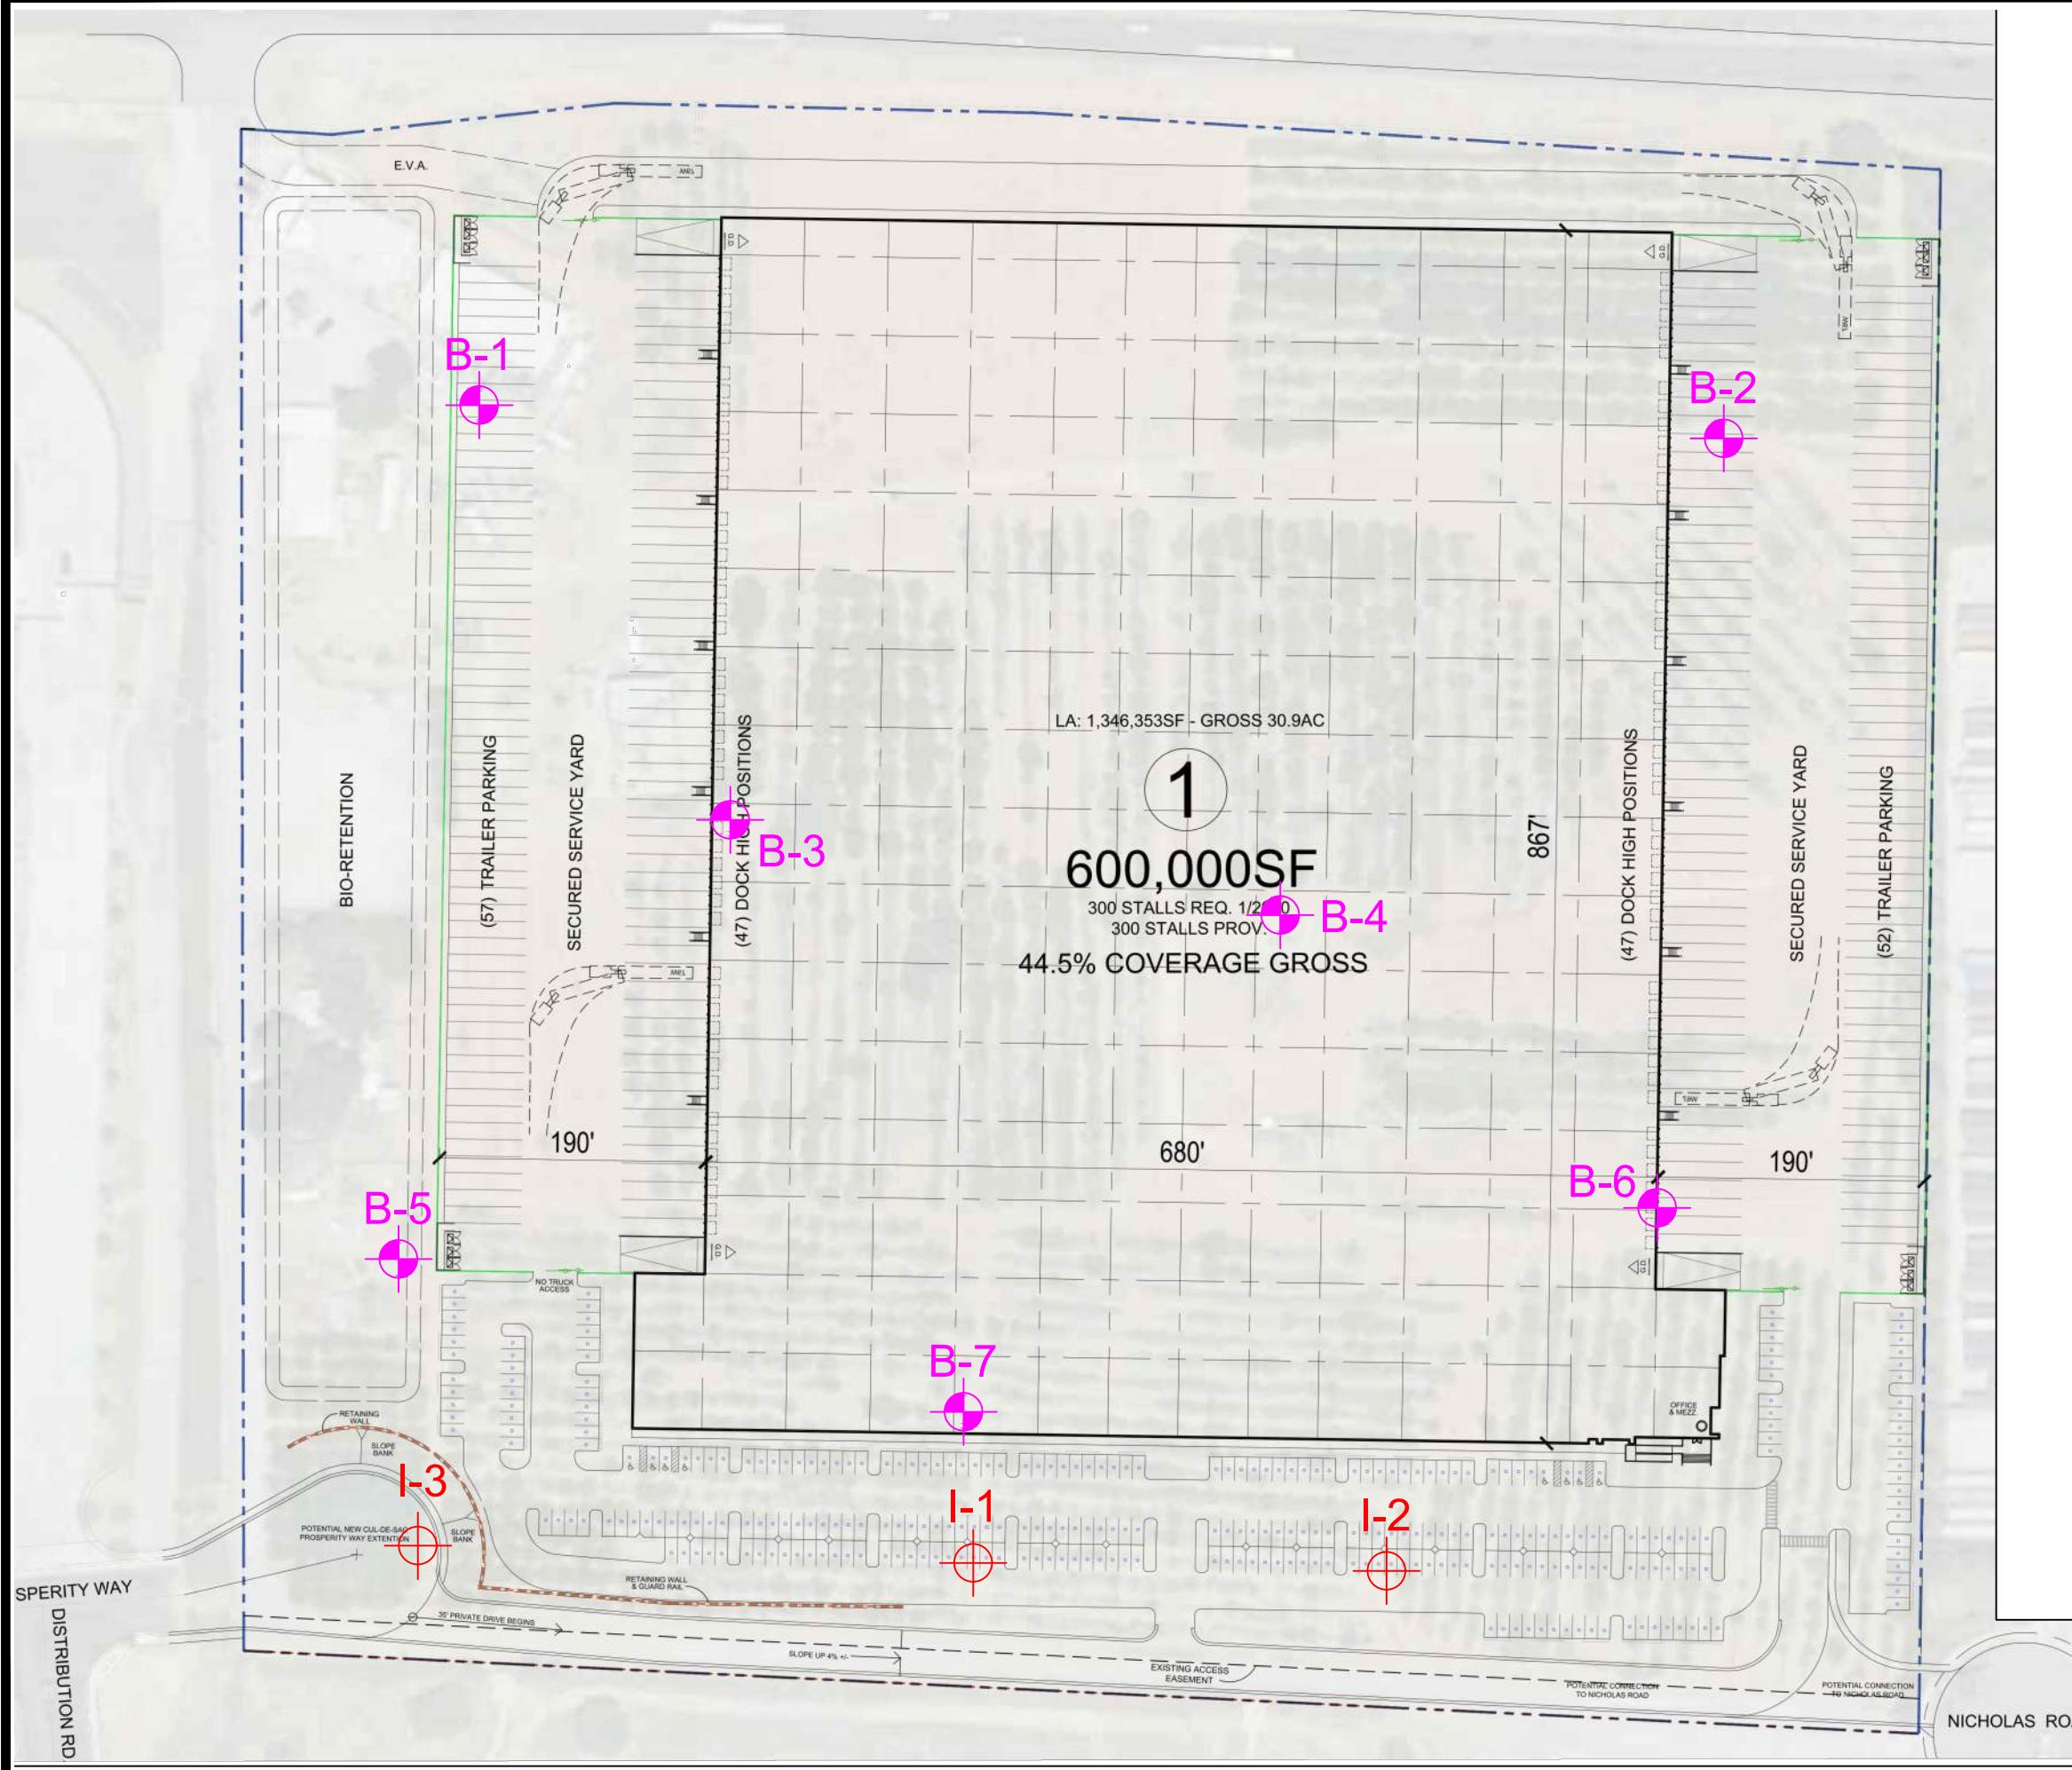
PLATE 2

- APPROXIMATE INFILTRATION LOCATION
- APPROXIMATE BORING LOCATION
(SCG PROJECT NO. 21G254-1)

INFILTRATION TEST LOCATION PLAN

The subsurface exploration conducted for the infiltration testing consisted of three (3) infiltration test borings, advanced to a depth of $15\pm$ feet below the existing site grades. The infiltration borings were advanced using a truck-mounted drilling rig, equipped with 8-inch-diameter hollow stem augers and were logged during drilling by a member of our staff. The approximate locations of the infiltration test borings (identified as I-1 through I-3) are indicated on the Infiltration Test Location Plan, enclosed as Plate 2 of this report.

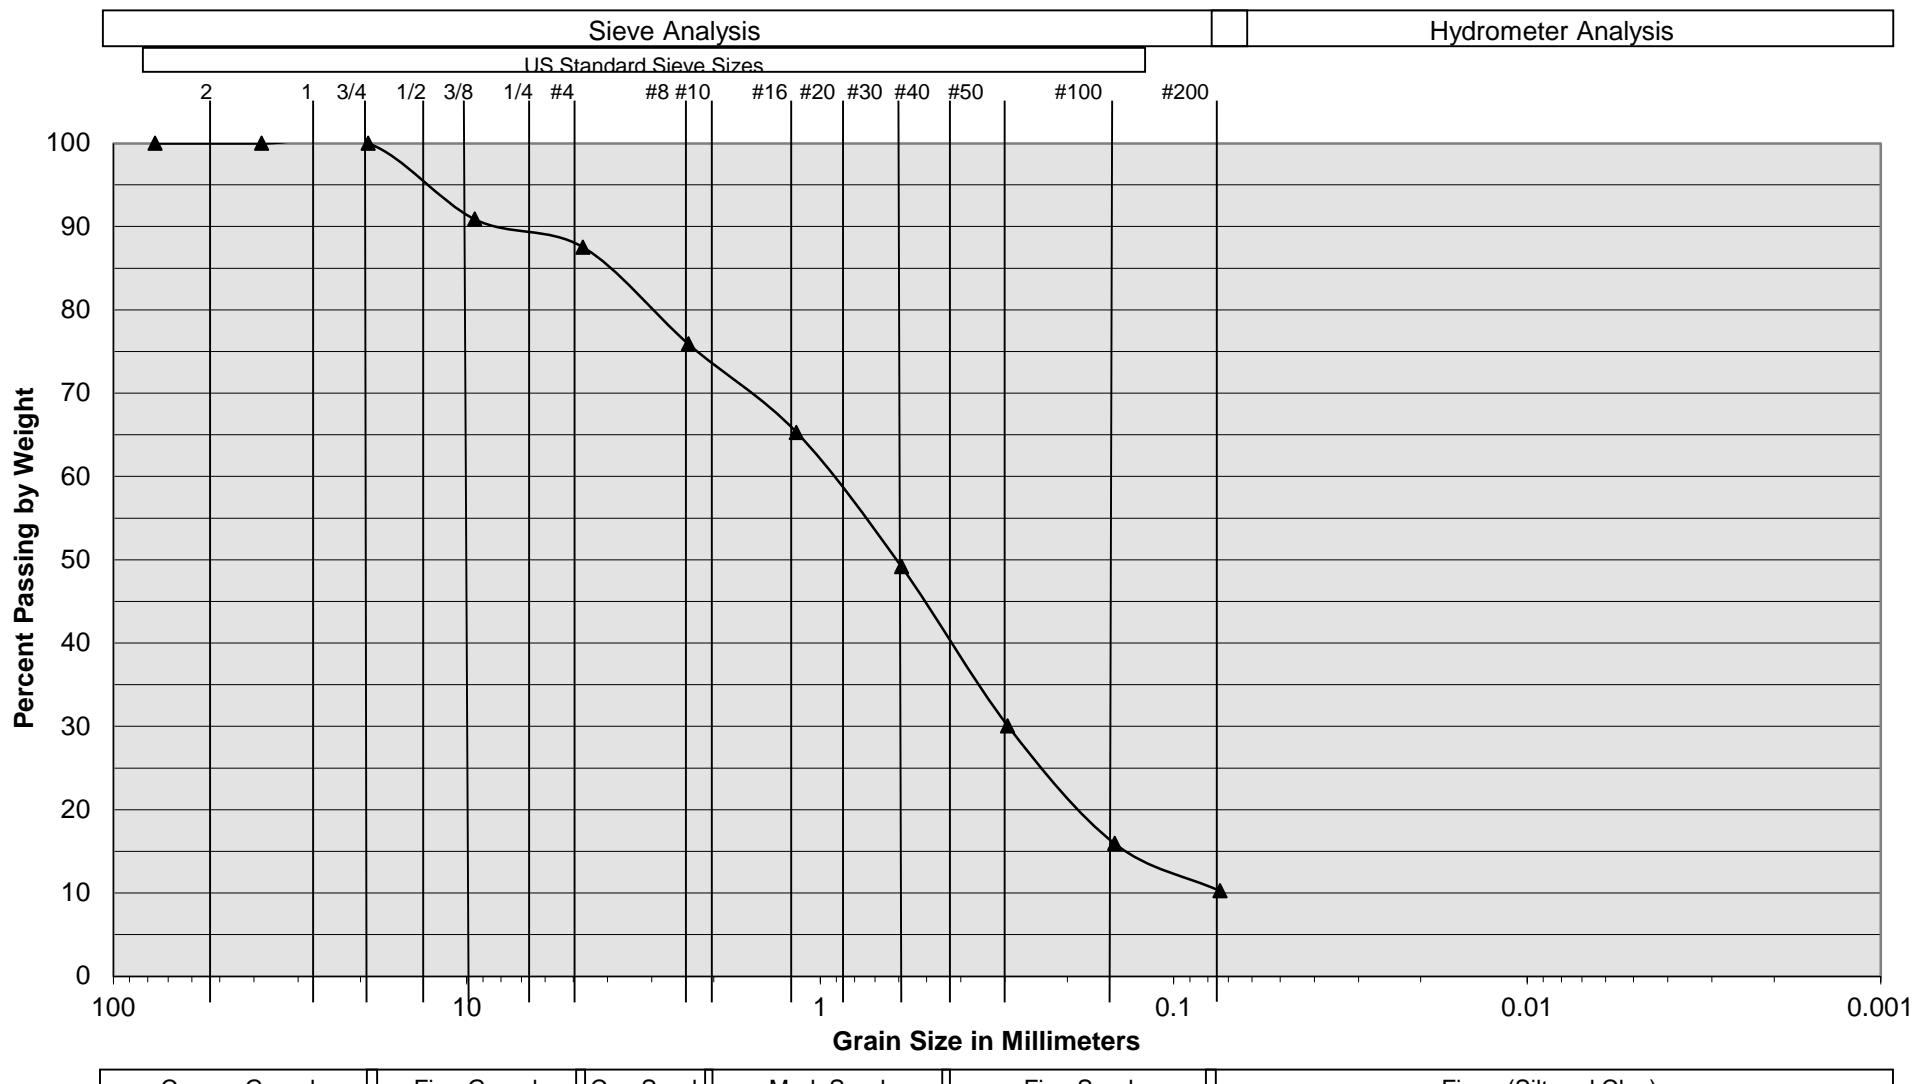
Grain Size Distribution

I-1 @ 13½'

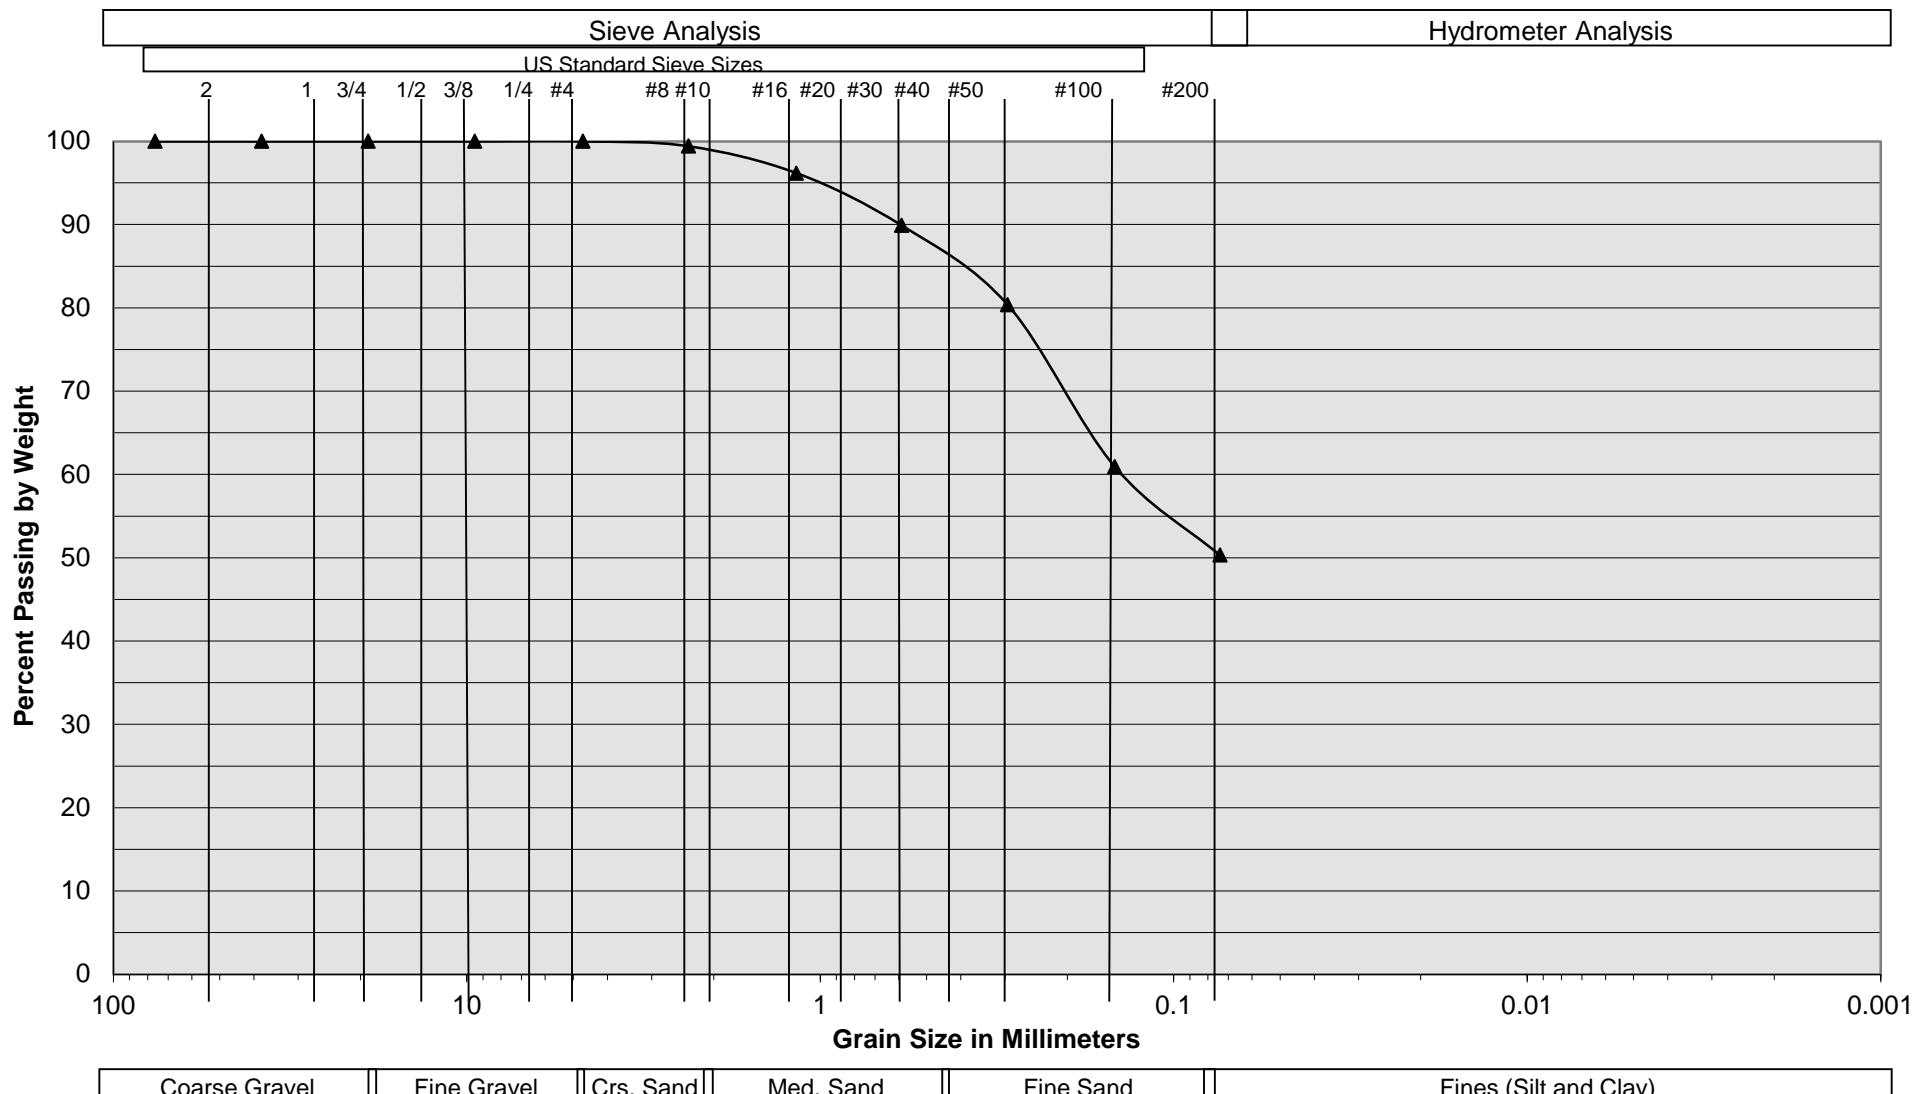
Grain Size Distribution

I-2 @ 13½'

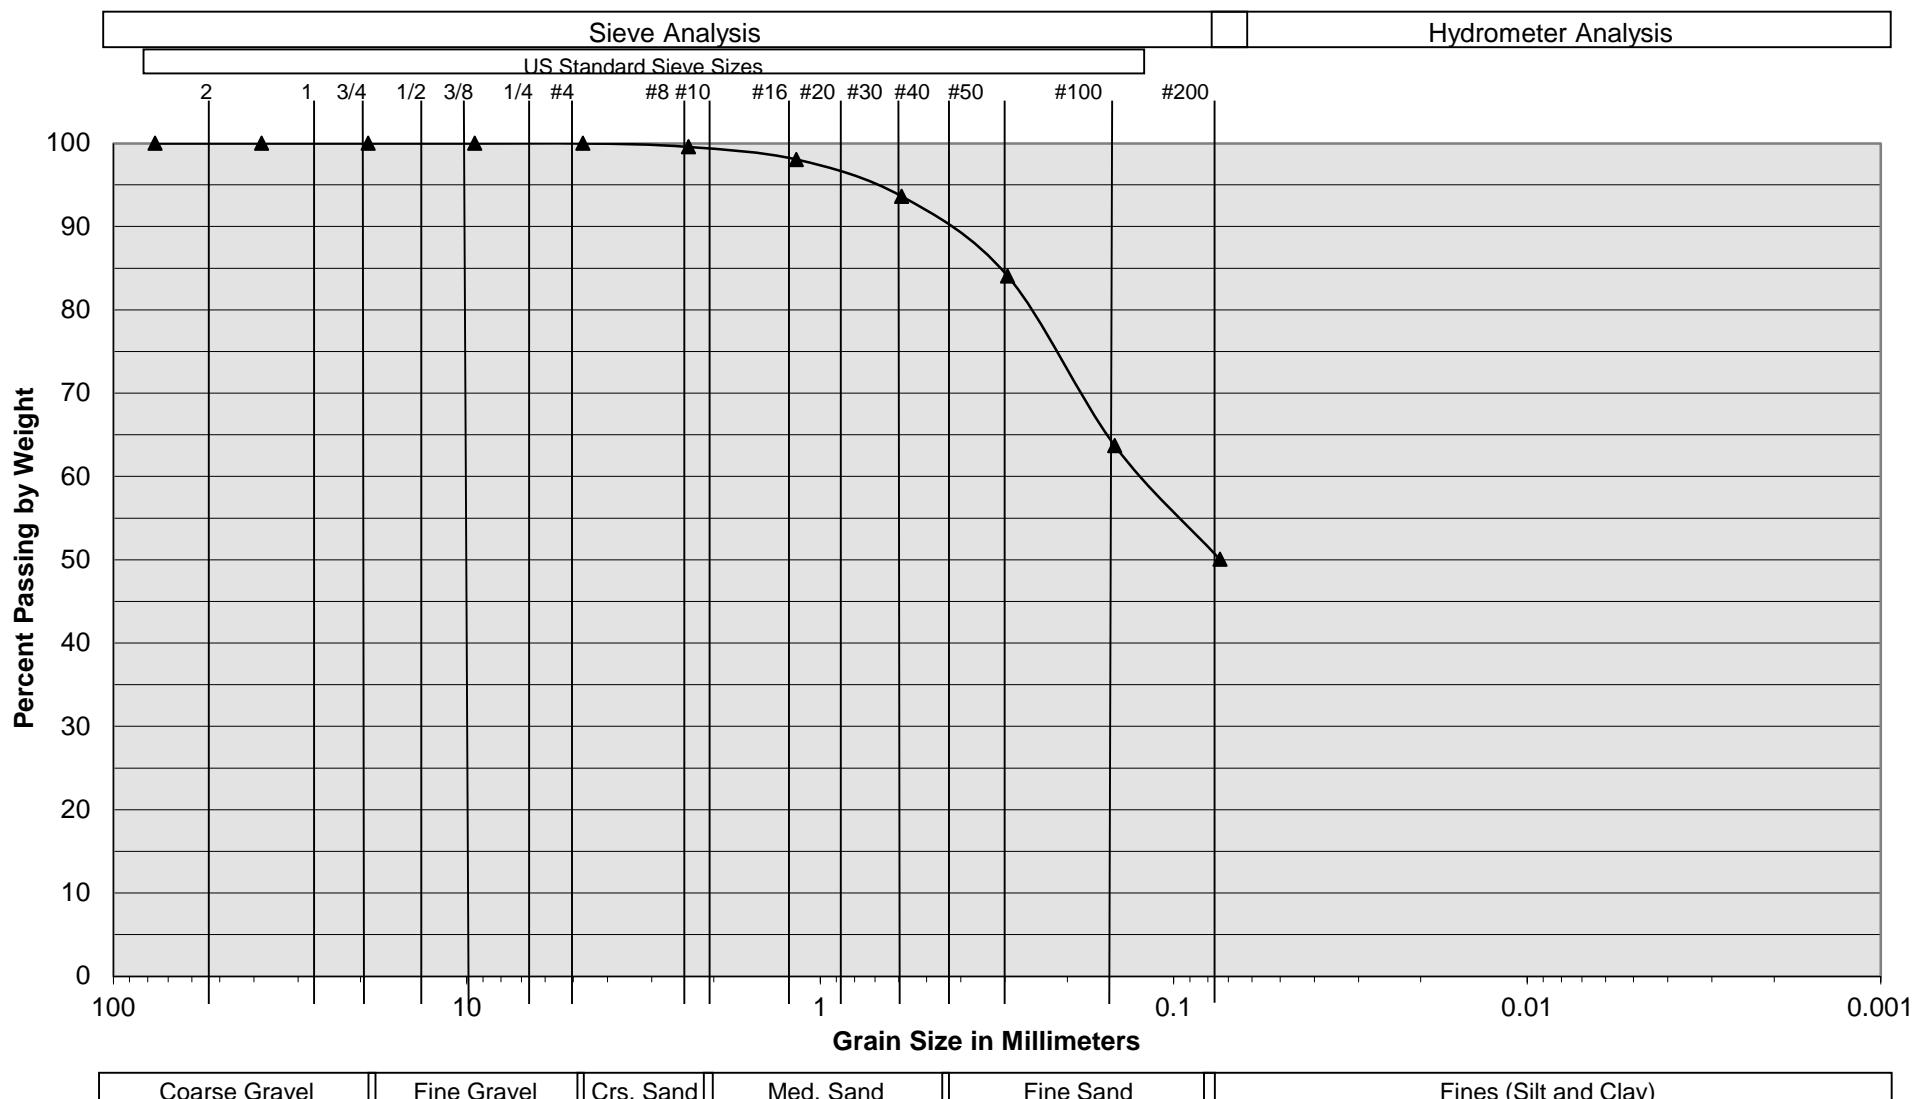
Grain Size Distribution

I-3 @ 13½'

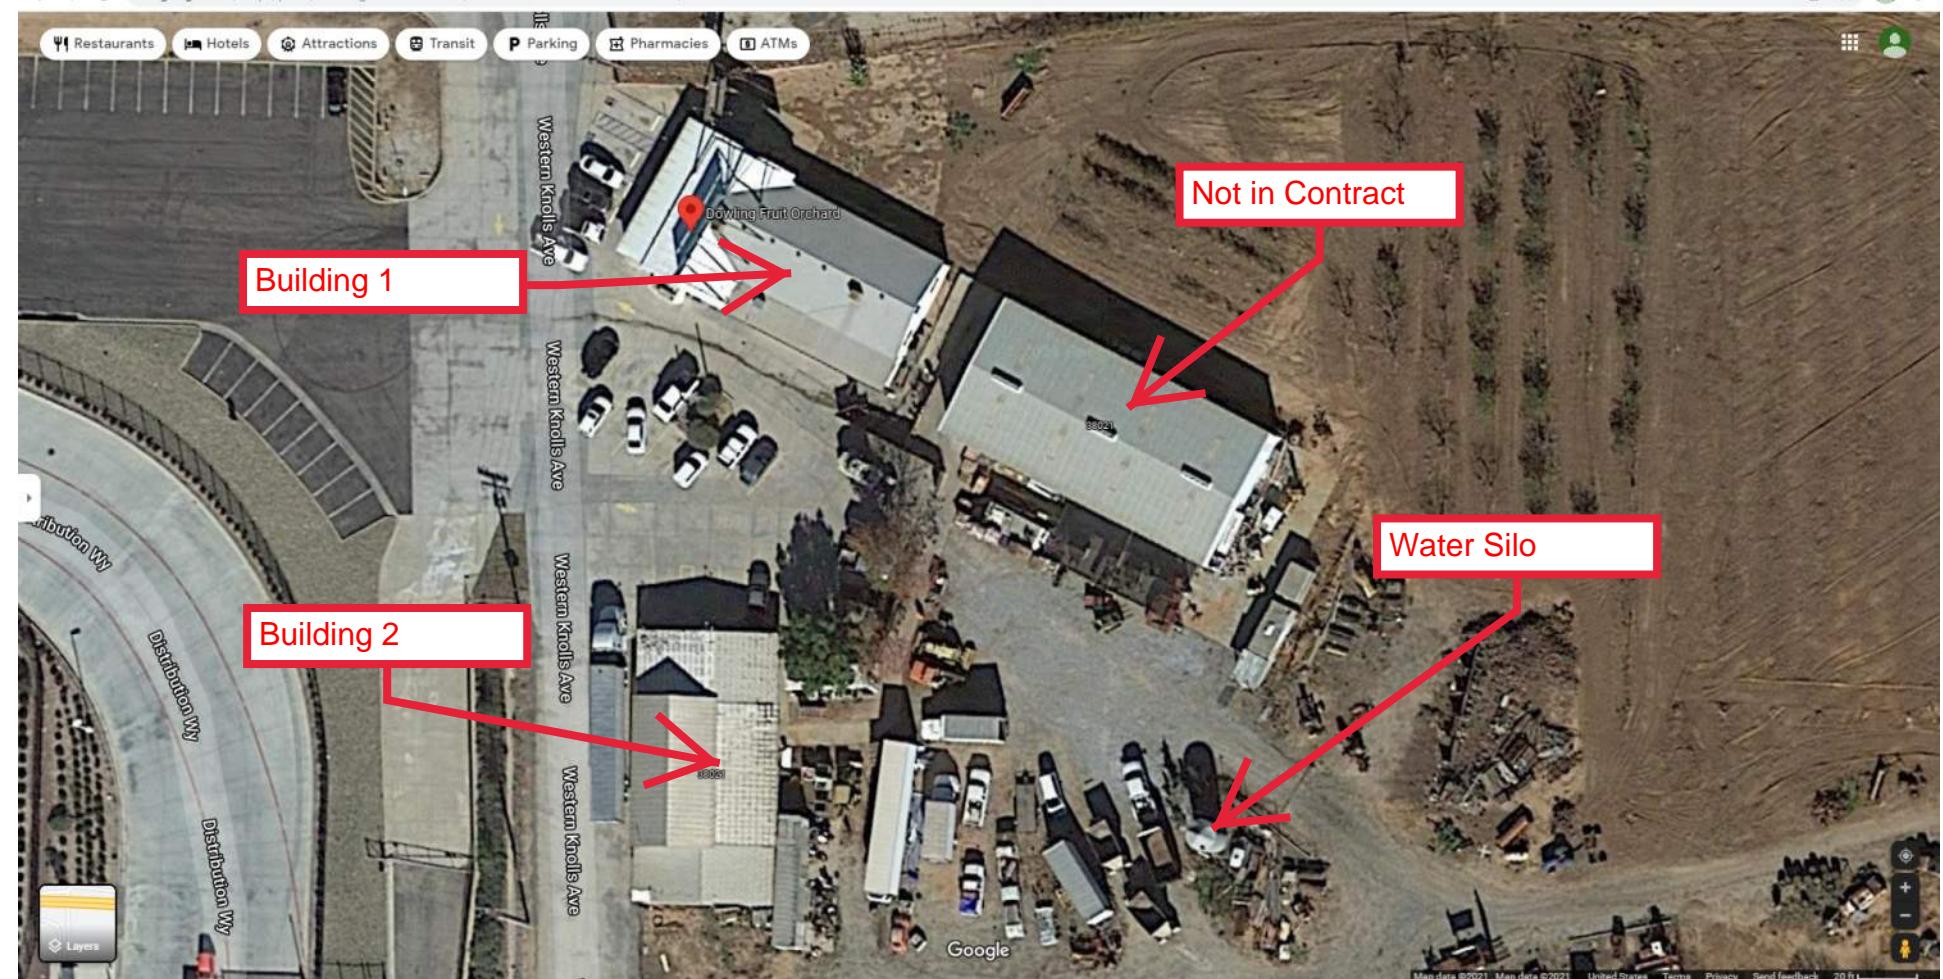
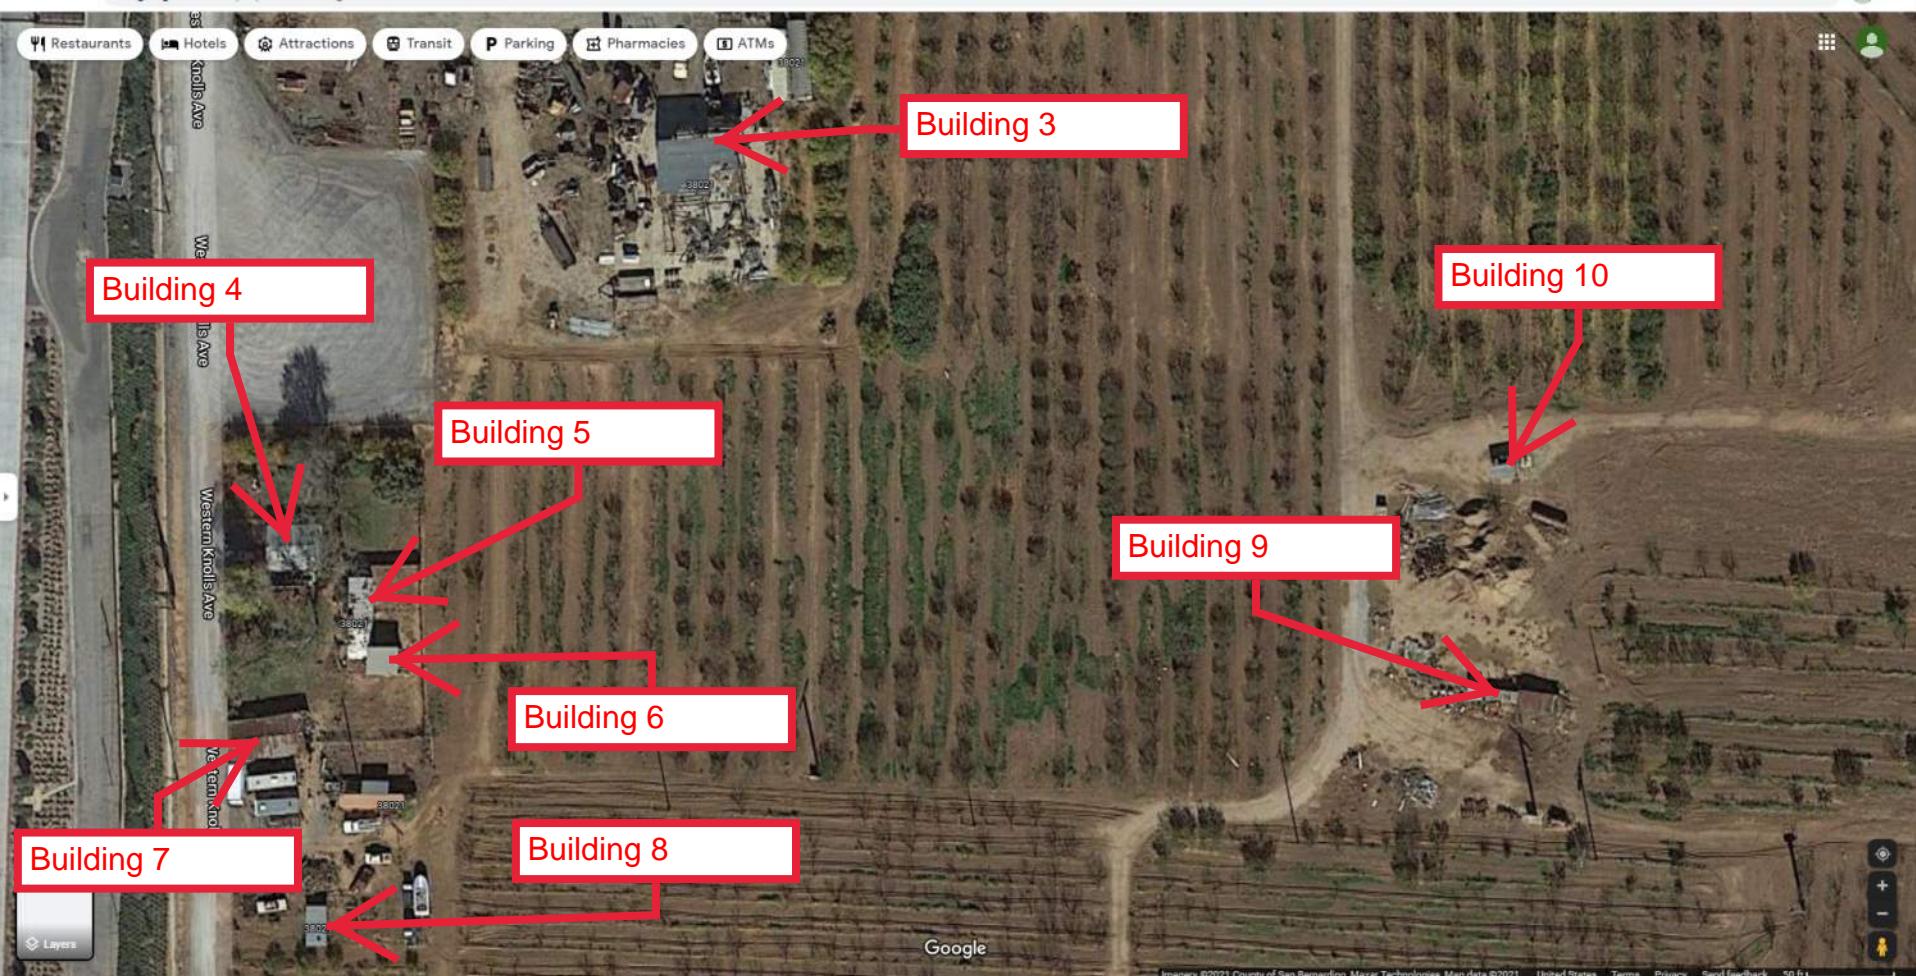
Dowling Ranch
Site Plan Page 2

Drawings with Bulk Sample Locations

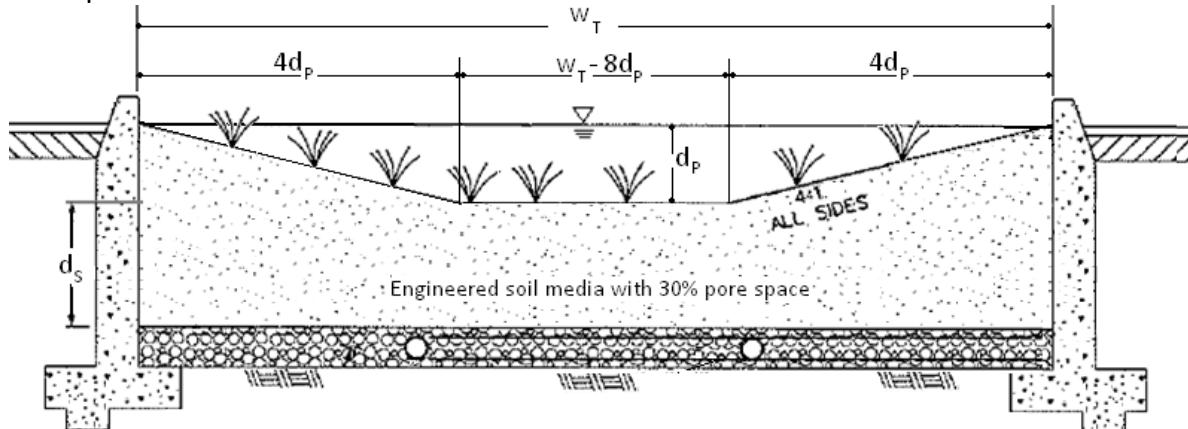
- 5) Enter the top width of the Bioretention Facility.
- 6) Calculate the total effective depth, d_E , within the Bioretention Facility. The maximum allowable pore space of the soil media is 30% while the maximum allowable pore space for the gravel layer is 40%. Gravel layer deeper than 12' will only get credit for the pore space in the first 12'.

- a. For the design with side slopes the following equation shall be used to determine the total effective depth. Where, d_P is the depth of ponding within the basin.

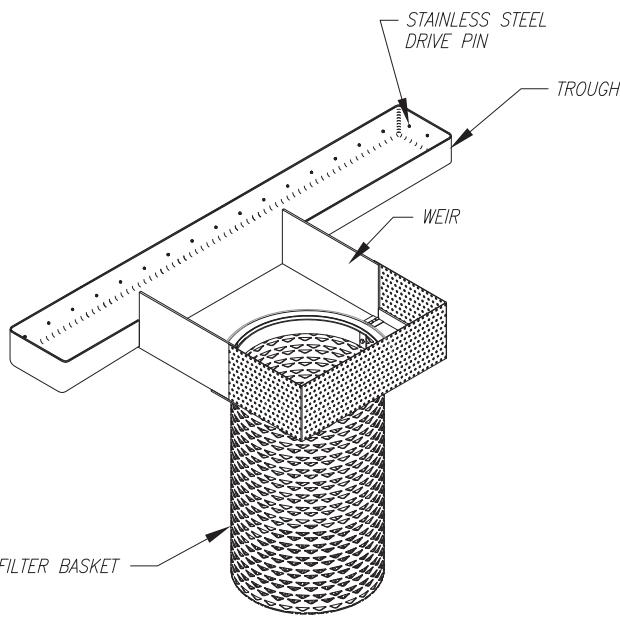
FIGURE 1:
DETAIL OF PARTS

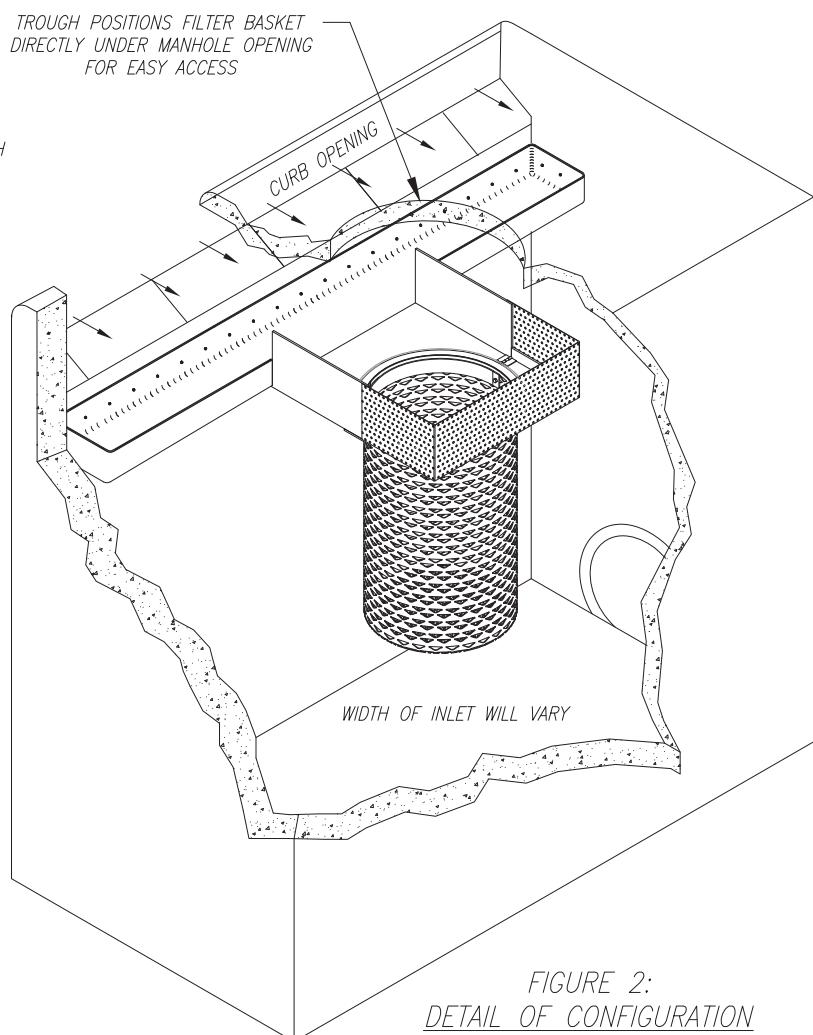
FIGURE 2:
DETAIL OF CONFIGURATION

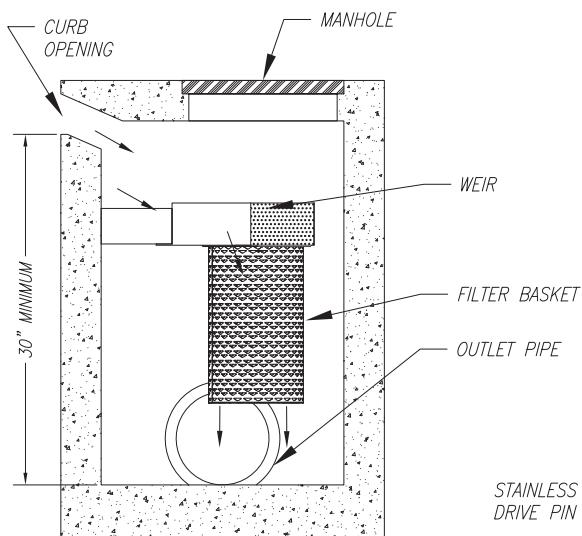
FIGURE 4:
DETAIL OF PROFILE
